MARINE INVESTIGATION REPORT
M13W0057

STRIKING OF THE HMCS WINNIPEG

FISHING VESSEL *AMERICAN DYNASTY*
ESQUIMALT, BRITISH COLUMBIA

23 APRIL 2013

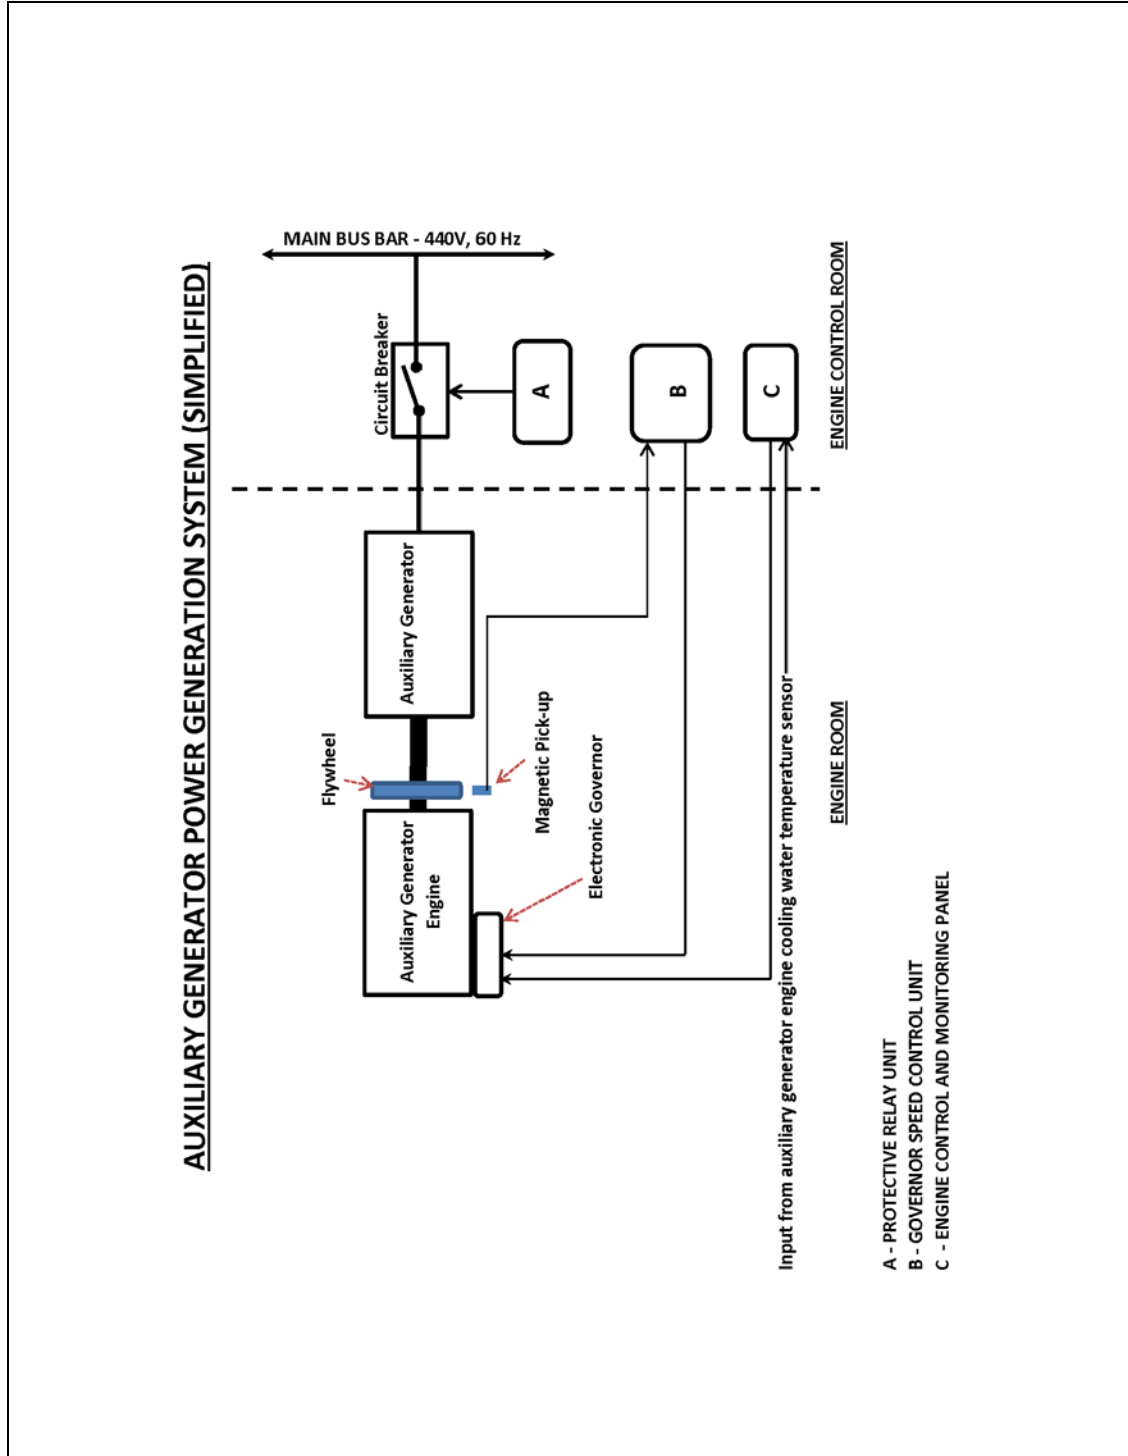
Appendix D – Main power generation

On the *American Dynasty*, main electrical power can be provided by either the shaft generators, the auxiliary generator,²¹ or all 3 simultaneously. At the time of the occurrence, the auxiliary generator was in use. The auxiliary generator is driven by a diesel engine that is fitted with a protective relay unit²² as well as an engine control and monitoring panel that can be used to check engine parameters such as the engine cooling water temperature (Appendix D).

Post-occurrence, the face of the magnetic pick-up was found to be damaged. In addition, the auxiliary engine's speed sensing failsafe unit (located inside the electronic governor's speed control unit) was found to be bypassed by a jumper wire. Bypassing the speed sensing failsafe unit would deactivate the failsafe circuit and would prevent the engine from shutting down.

Although the exact reason for the blackout could not be determined,³¹ the most likely cause was a damaged magnetic pick-up of the auxillary generator speed control unit. This damage resulted in the intermittent transmission of signals from the the magnetic pick-up to the speed control unit. The speed sensing part of the control unit was also bypassed by a jumper wire.³² When this part of the control unit is bypassed, it is unable to shut down the engine if the magnetic pick-up is malfunctioning, allowing fluctuations in the electrical frequency to occur. Furthermore, when the bow thruster motor was switched off, a large load was suddenly taken off the auxillary generator, which may have caused the frequency to fluctuate above the maximum limit of the protective relay unit.

- Posted an operating procedure to ensure that the emergency generator is set to start automatically;
- Replaced the non-functional set of emergency back-up batteries;
- Replaced the magnetic pick-up sensor and governor speed control unit;
- Tested the auxiliary generator engine for all alarms and tripping functions;
- Overhauled the pitch control oil distribution box; and
- Replaced the pitch control actuator.
