MARINE INVESTIGATION REPORT
M15A0009

BOTTOM CONTACT
ROLL-ON ROLL-OFF PASSENGER FERRY *GRACE SPARKES*
BURNSIDE, NEWFOUNDLAND AND LABRADOR
21 JANUARY 2015

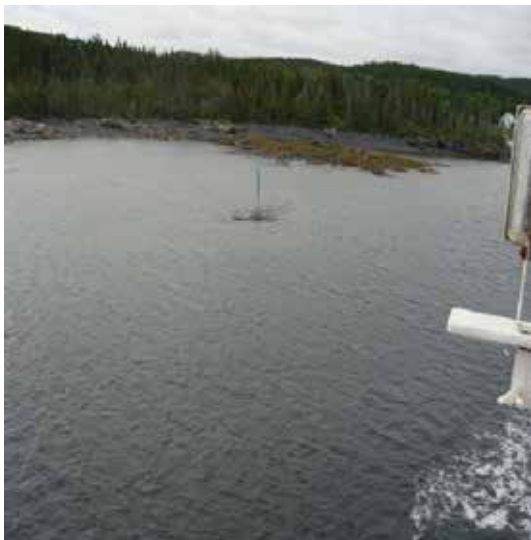
There were 2 starboard-hand buoys and 1 port-hand marker in the area of the occurrence (Photo 2 and Photo 3). The 2 buoys indicated the starboard boundary of the channel. The marker indicated the location of Burnside Rock, but did not indicate the port boundary of the channel.

Photo 3. Port-hand marker on Burnside Rock

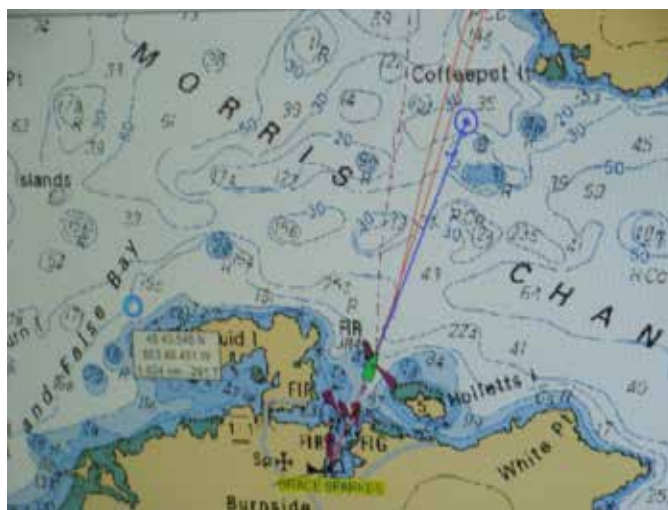
Photo 4. Raster chart of area of occurrence

The raster chart in use at the time of the occurrence did not have any courses or waypoints entered for the voyage.

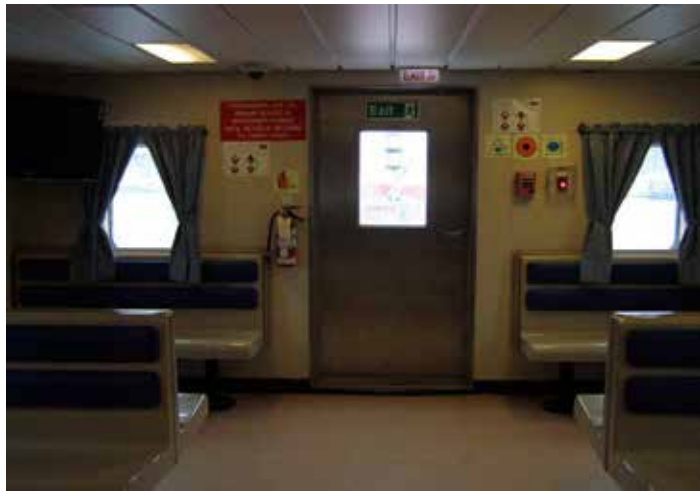
The lifejackets on board the *Grace Sparkes* were stowed on deck, aft of the passenger lounge, in labelled orange stowage crates. The crates were visible from inside the lounge, but only to a person standing by the aft exit door looking out (Photo 5) in the direction of where they were stowed. The lounge had signage indicating donning instructions for the lifejackets. However, there was no signage indicating where the lifejackets or lifejacket containers were located, nor was there any regulatory requirement to indicate, by signage, the directions to the lifejackets.

Photo 5. Aft exit of passenger lounge (lifejackets outside door on deck but no signage)

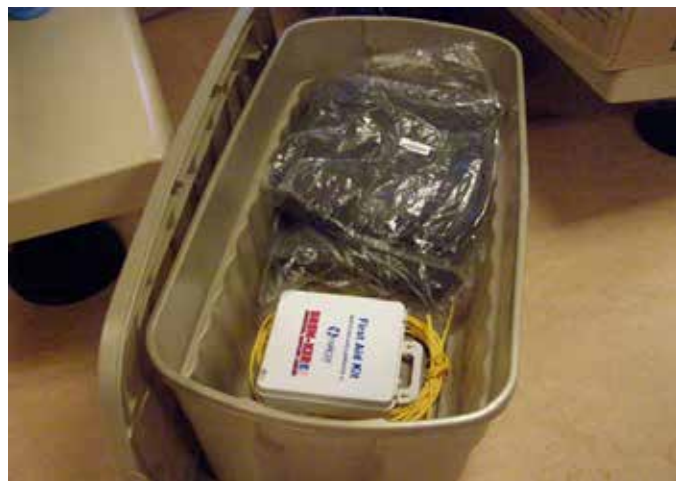
The *Grace Sparkes* was equipped with first aid kits, defibrillators, and other first aid equipment, but not all of this equipment was readily visible. The first aid kit in the passenger lounge was stowed in an unmarked container (Photo 6), and other first aid equipment, such as a defibrillator and an eye wash station, was stowed on the wall of a corridor on the boat deck forward of the passenger lounge. The equipment in the corridor was not visible from the seating area in the lounge, and there was no signage to indicate its location. Other lifesaving equipment, such as a loud hailer and smoke signals, was stowed in unmarked cupboards.

Photo 6. First-aid kit stowed in unmarked container

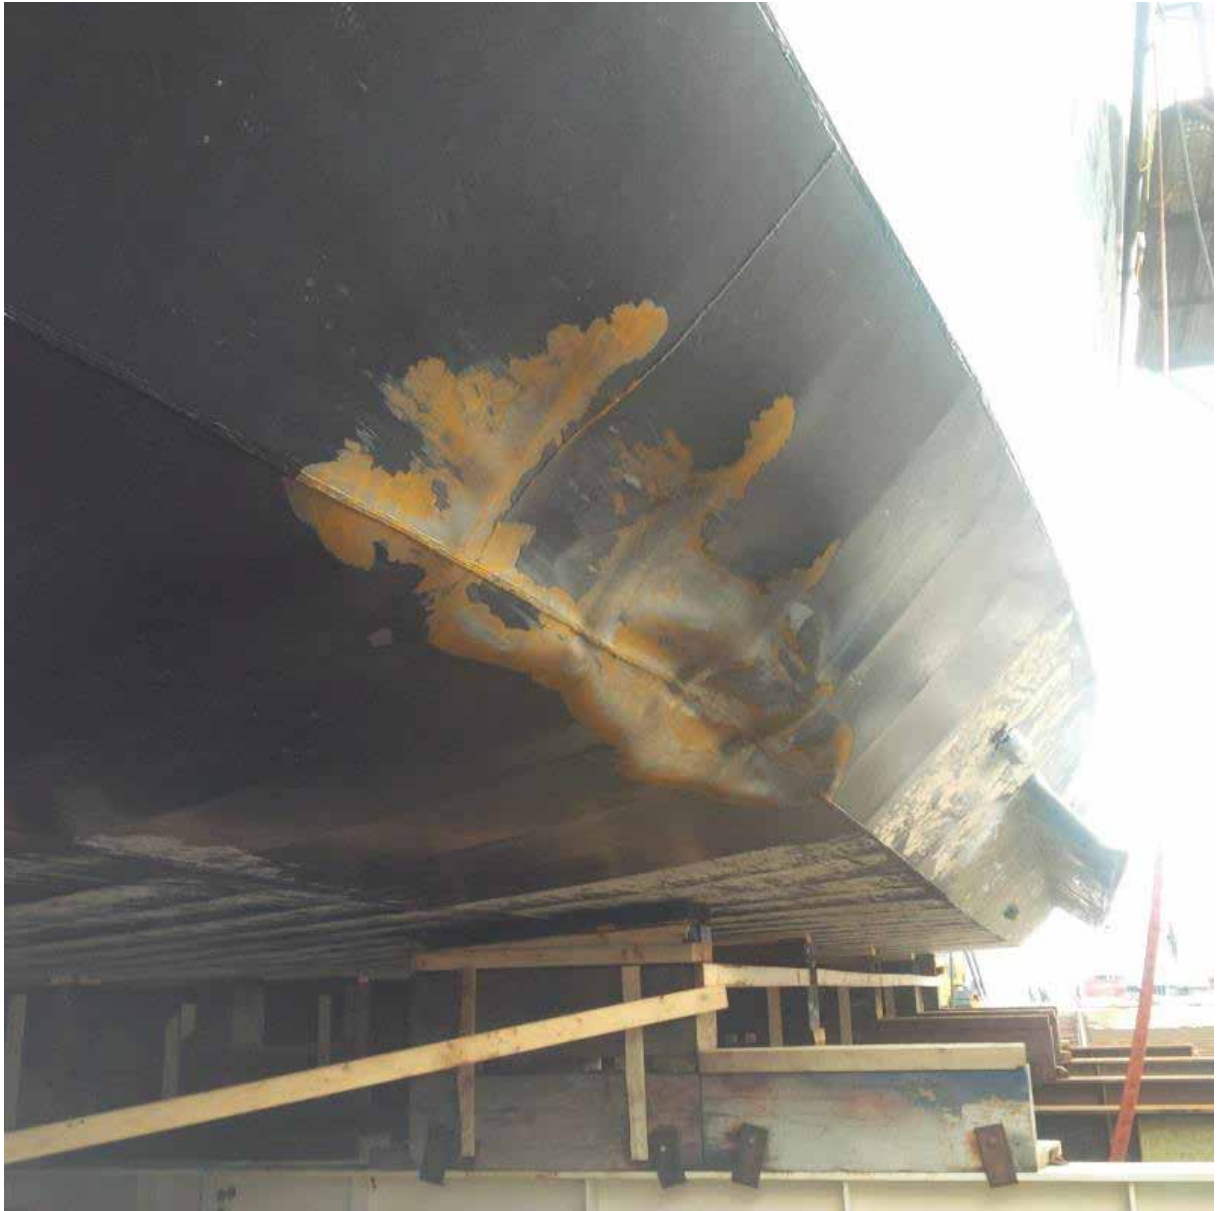
Appendix C – Shell plating damage

The *Grace Sparkes* sustained damage to an area of the hull measuring 3 m² from frames 51 to 56. The damaged area was at the lower chine,⁴ measured 300 mm wide, and included several internal framing members (Appendix C).

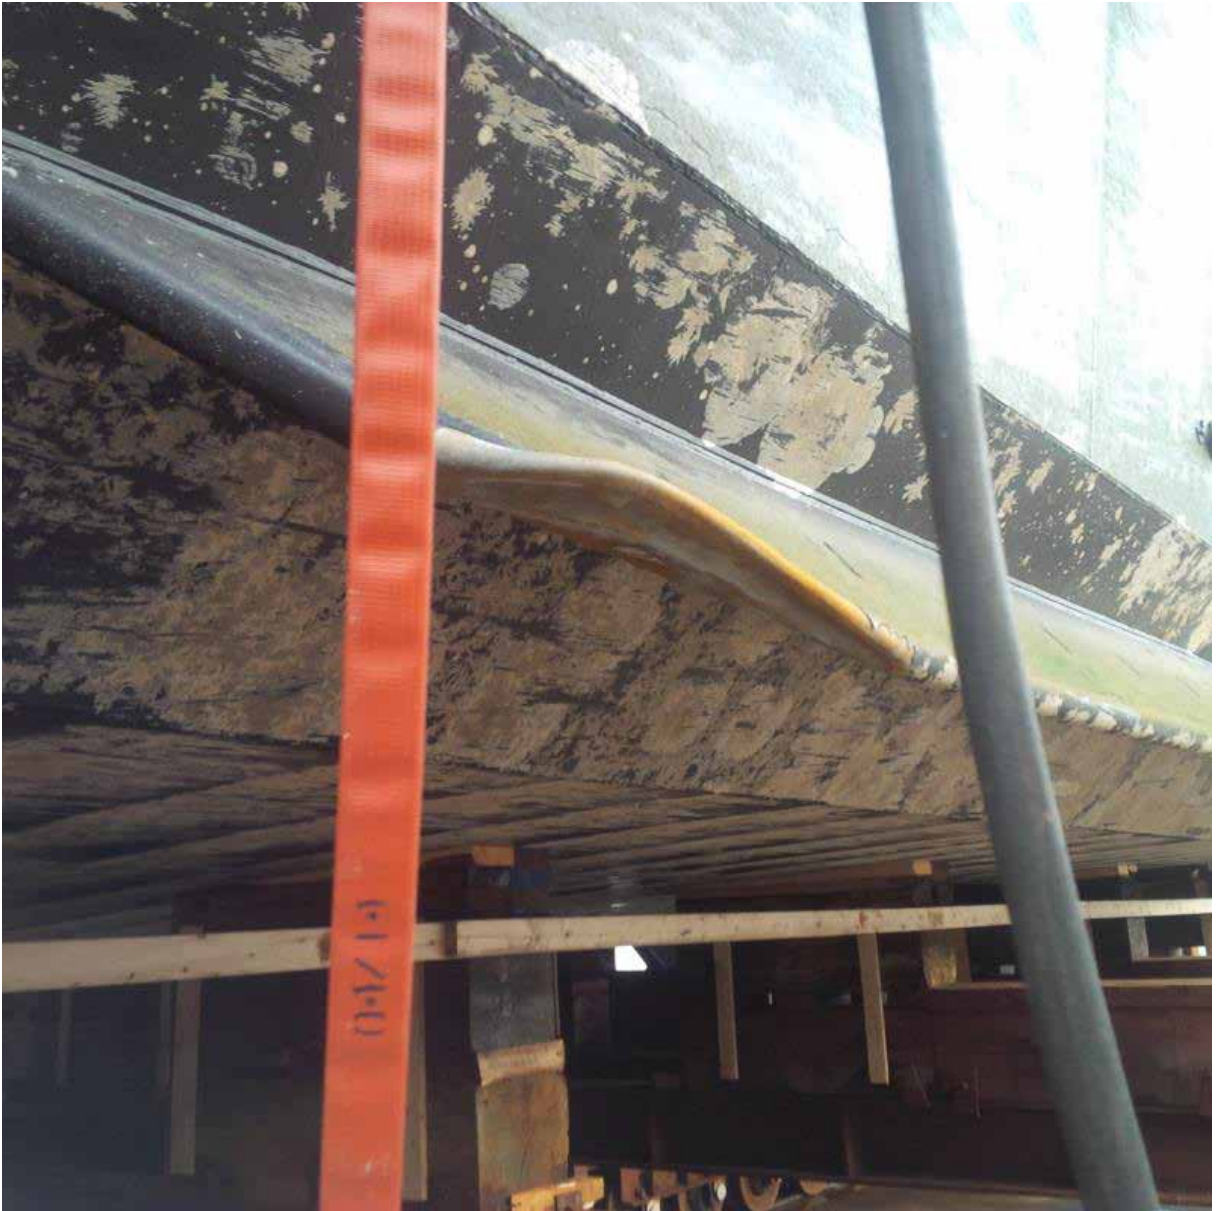
Appendix D – Bilge keel damage

In addition, the forward end of the bilge keel was damaged on the outer edge from frames 44 to 47 (Appendix D).
