## MARINE INVESTIGATION REPORT M15A0348

### **Person overboard and subsequent loss of life**

Small fishing vessel *Cock-a-Wit Lady*  
23 nautical miles SSW of  
Clark's Harbour, Nova Scotia  
30 November 2015

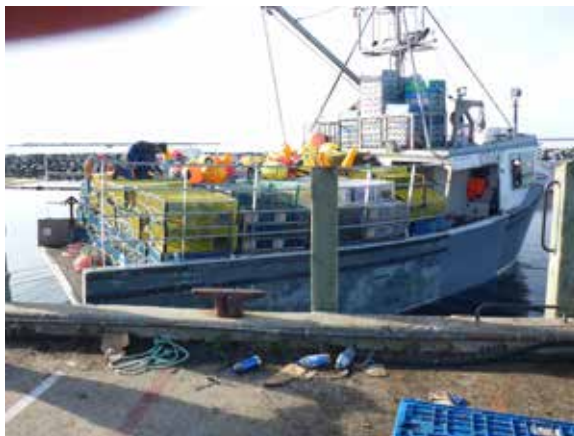
The vessel has an open stern to facilitate the setting of lobster traps (Photo 2). A permanent aluminum rail is fitted on the starboard side. A temporary rail of equal scantlings<sup>1</sup> is fitted on the port side and is used only at the beginning and end of the lobster season, to provide stability for the traps on deck. A cargo boom with a small winch is mounted on top of the wheelhouse. There is a trap hauler on the starboard side with a block located above it that can be raised or lowered into position for use. The vessel is used primarily for fishing lobster and longlining.

Photo 2. The *Cock-a-Wit Lady* in a partially loaded condition

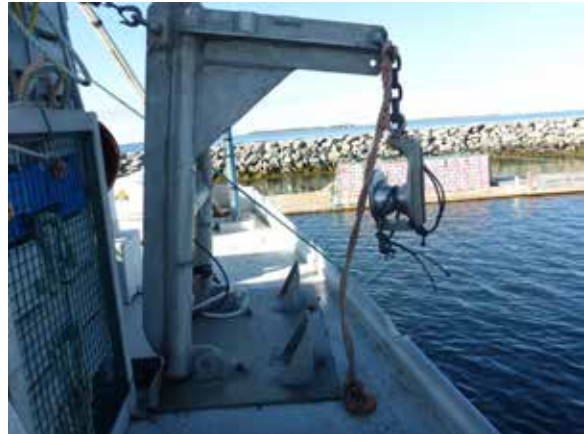
Photo 3. Overhead block in raised position

While they were under way, the crew lowered the overhead block that is mounted on top of the wheelhouse and above the trap hauler (Photo 3). They began hauling from this end and, after retrieving 3 traps, they brought up the deckhand who had fallen overboard. At approximately 0905, after being underwater for approximately 10 minutes, the deckhand was recovered and brought on board. As no pulse was detected, cardio-pulmonary resuscitation was administered immediately.

As the *Cock-a-Wit Lady* was intending only to set traps on the day of the occurrence, the overhead block was not lowered into the horizontal position; it was lowered only when it was intended to be used for hauling traps. Performing regular emergency drills would provide an opportunity for crew members to identify shortcomings in the retrieval of a person overboard, such as the fact that, in the vertical or raised position, the overhead block was not available for immediate use to haul a person overboard and that, when lowered, the block allowed for the most efficient angle for hauling the heavy traps and the weight of the person in the water.
