MARINE INVESTIGATION REPORT

M16P0062

Grounding of barges

Tug *H.M. Scout* towing barges *HM Blue Horizon*
and *HM Tacoma*

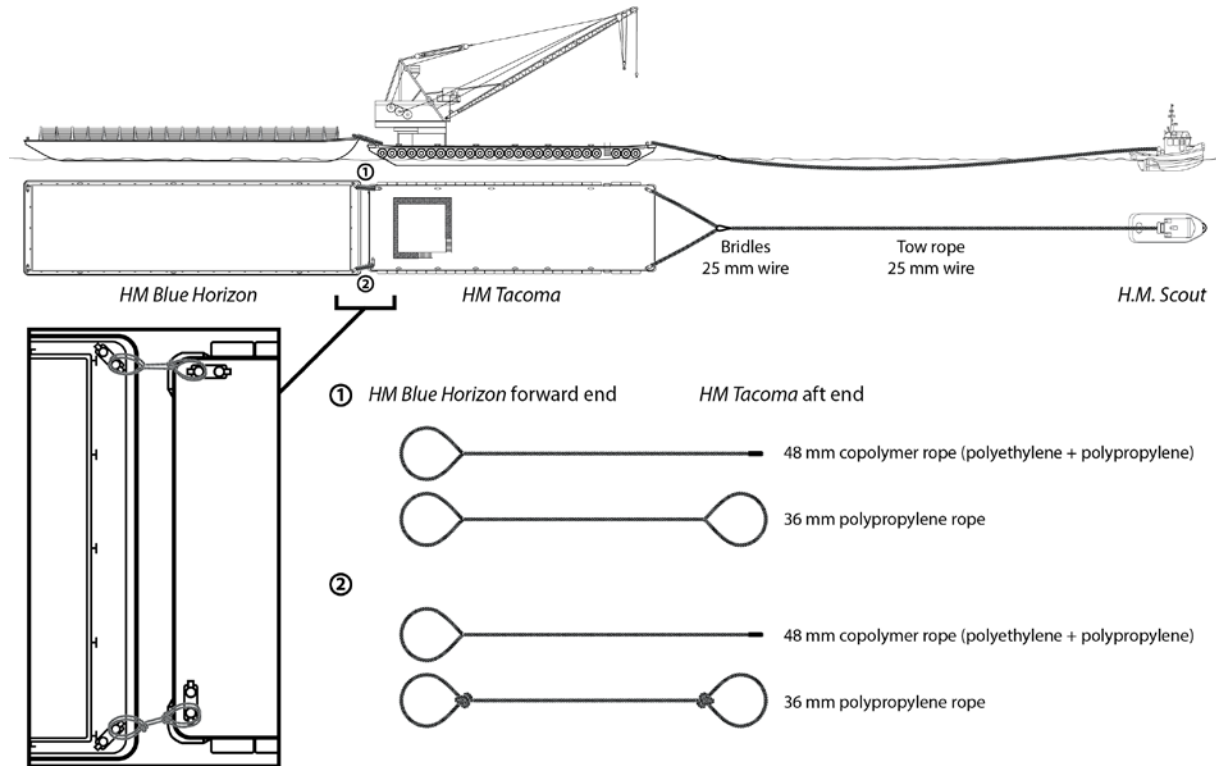
Figure 4. Towing arrangement

The *HM Tacoma* was connected to the tug *H.M. Scout* by a wire tow rope and wire rope bridles. The complete wire tow rope aboard the *H.M. Scout* was 198 m long, and an unknown length was paid out upon departure from Ogden Point. For benign and sheltered areas, Det Norske Veritas – Germanischer Lloyd (DNV–GL), formerly GL–Noble Denton, recommends that “the minimum deployable length shall not be less than 500 m and shall not include the

The *H.M. Scout* departed Victoria with the *HM Tacoma* and *HM Blue Horizon* in tandem tow. The 2 barges were connected using short, degraded synthetic fibre ropes of different diameter, length, and material. The ropes were made fast to bitts that were not aligned properly for towing and were not equidistant from the *HM Tacoma's* hull. The tow line between the tug and the first barge was also too short and did not provide catenary to dampen the effects of the dynamic motions between the tug and barge.

- Short, 3-strand synthetic fibre ropes (copolymer and polypropylene) were used.
- The synthetic fibre ropes were in poor condition.
- The towing bitts on the *HM Tacoma* were fitted dissimilarly, making it difficult for the crew to ensure that the ropes were of equal length and therefore that the load was distributed equally.
- The length of the tow wire between the tug and the *HM Tacoma* did not allow for sufficient catenary.
- The ropes between the barges did not allow for sufficient catenary.
- The tug's bollard pull had not been established, nor had the towing force of the barges been calculated to assess whether the tug and tow could safely complete the voyage in the forecasted weather conditions.

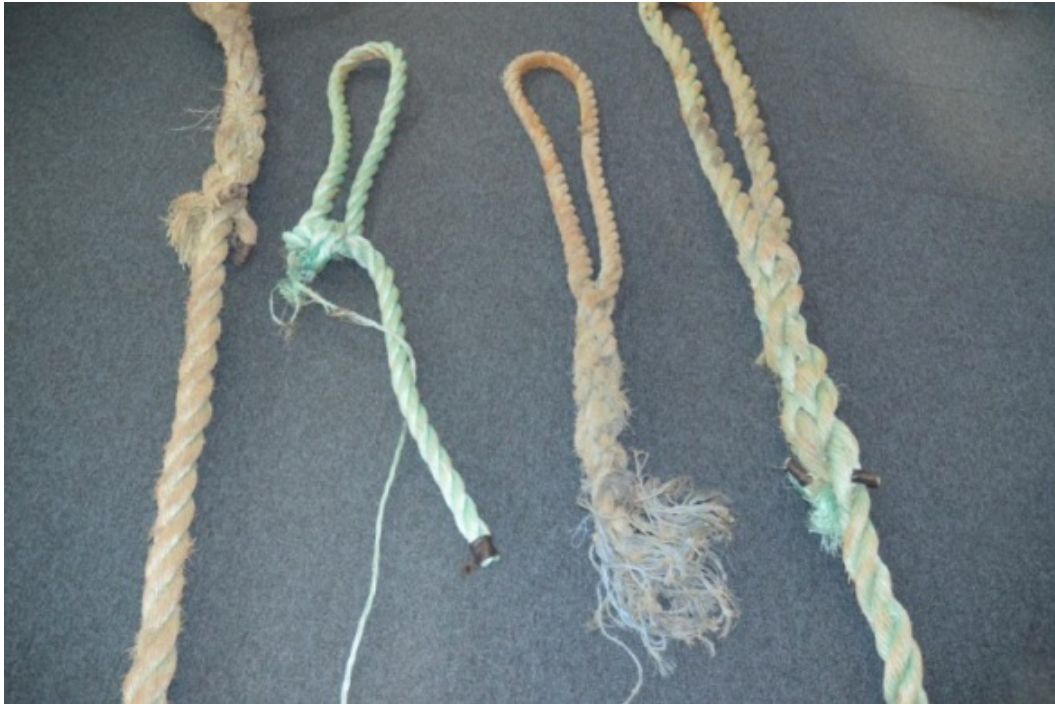
Following the occurrence, the 48 mm copolymer ropes were recovered from the *HM Blue Horizon* and were sent to a private test facility to check for residual strength.³³ One of the ropes failed at 16.9 tons and the second rope failed at 12.9 tons. A new 48 mm copolymer rope has a breaking strength of 35.3 tons.

Visually, the ropes appeared weathered and discoloured due to prolonged exposure to sunlight. There were numerous broken filaments all over the rope, which is consistent with abrasion and cyclic tension wear.³⁴ The fibres were stiff, brittle, and fused, which is consistent with shock load³⁵ or sustained high load. The eye splices had semi-permanent circular deformation similar to the width of bits and signs of chafing, fusion, and discolouration where the rope was wrapped around the bits. The eye splices were intact and the 4 ropes had separated closer to their midpoints than to their eye splices (Appendix D).

The 36 mm polypropylene ropes that were recovered were not of sufficient length to be tested. Visually, the 36 mm ropes showed signs of aging and wear similar to the 48 mm copolymer ropes. One of the 36 mm ropes had a knot in it that was used to make the eye.

Recovered 48 mm copolymer and 36 mm polypropylene rope pieces used for testing

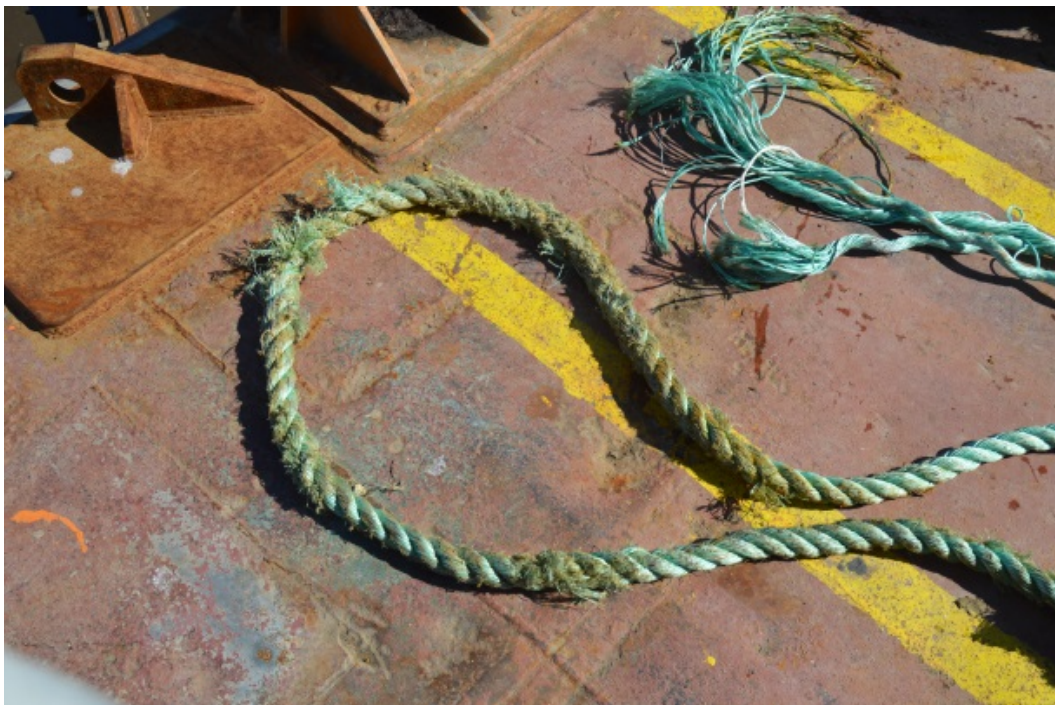
48 mm copolymer rope found on the *HM Tacoma*

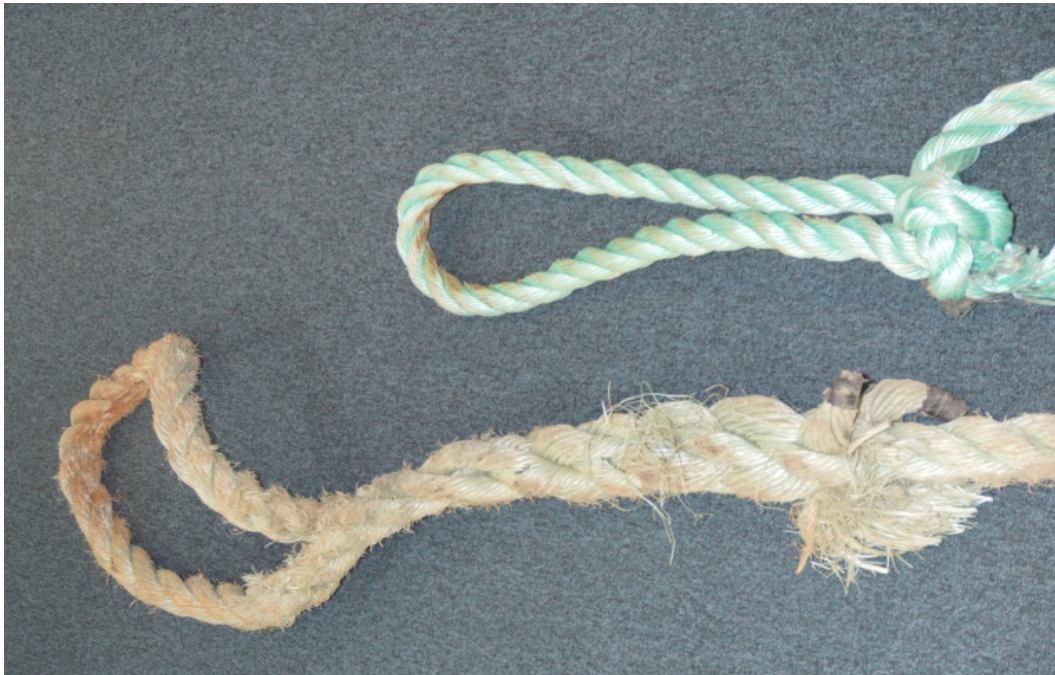
Deformed eye splice on 48-mm rope and knot in 36-mm rope

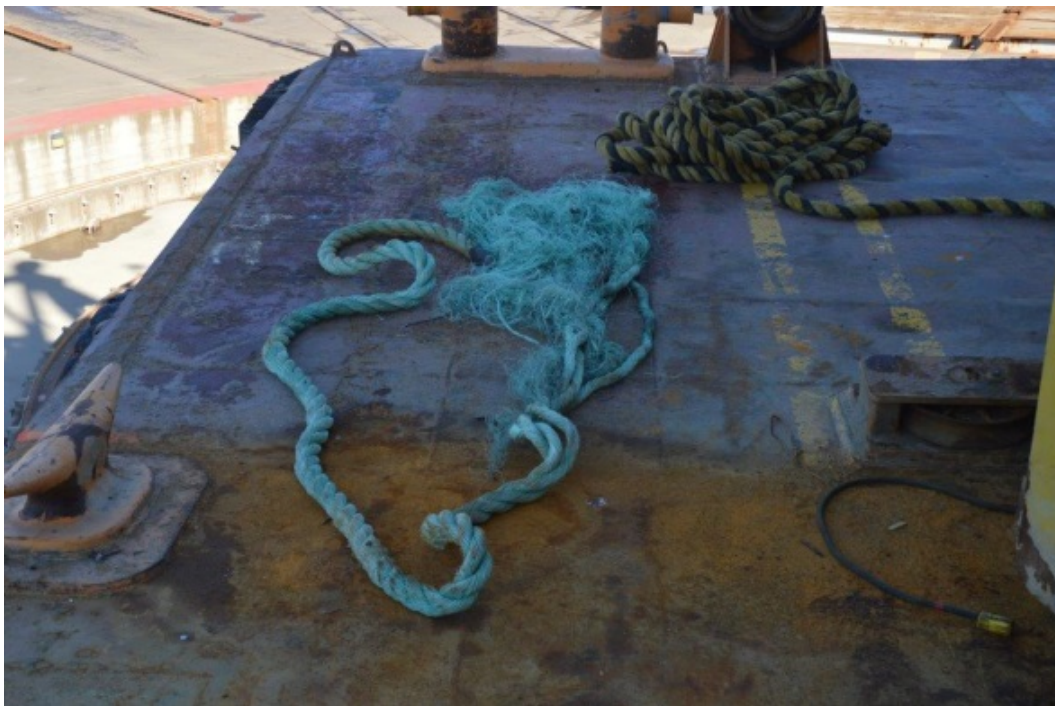
3. The tug and tow encountered the forecasted gale-force winds and rough sea conditions, and the combined forces of these movements caused the ropes between the barges to part; the *HM Blue Horizon* drifted free and went aground.

Parted 48 mm copolymer rope with frayed end on the *HM Tacoma*
