MARINE INVESTIGATION REPORT
M14C0193

STRIKING OF THE BREAKWATER
TUG *VACHON* AND BULK CARRIER *ORIENT CRUSADER*
PORT-CARTIER, QUEBEC
12 SEPTEMBER 2014

Marine Investigation Report M14C0193

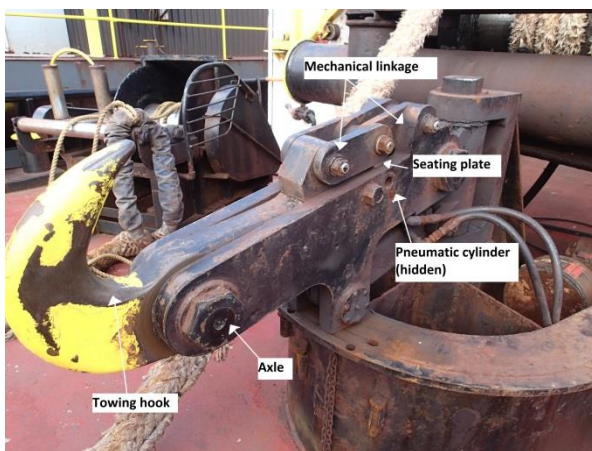
Figure 1. Towing hook and tow-abort mechanism in working position

The *Vachon* is fitted with a tow-abort mechanism for the towing hook that can be activated from either the port or the starboard conning position. The tow-abort mechanism is designed to function when the tow line is under tension. When the towing hook is in the working position, its mechanical linkage rests in a horizontal position on seating plates (Figure 1). When the tow-abort button at the conning position is pressed, compressed air is sent into a pneumatic cylinder that pushes the mechanical linkage upward and causes the towing hook to spin on its axle and release the tow line (Figure 2).

During routine towing operations, the tow-abort mechanism was used to release the tow line when it was under reduced tension.

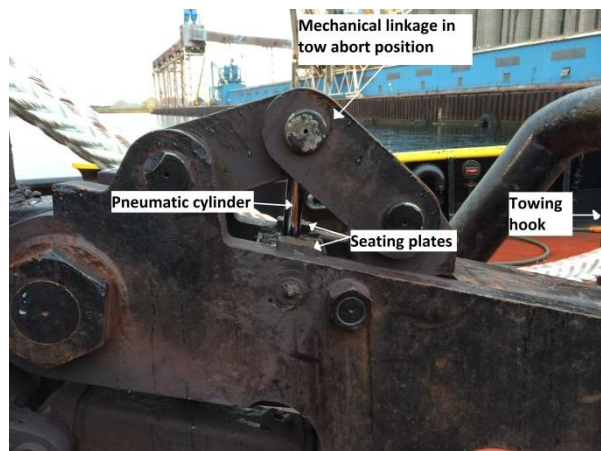
Figure 2. Mechanical linkage of tow-abort mechanism in tow-abort position (Photo: Jean-Daniel Hogan)

Following the occurrence, the company examined the towing hook on the *Vachon* and observed that the seating plates for the mechanical linkage were recessed, causing the linkage to rest below its normal horizontal position (Appendix C). The TSB conducted a release test to determine at what point the tow-abort mechanism functioned. The test determined that the mechanism only operated when the applied tension was approximately 10 tonnes or less. TC and the company subsequently conducted a release test on the *Brochu*, with the same results.

The investigation could not determine at what point in time the tow-abort mechanism had ceased to function when the applied tension in the tow line was greater than 10 tonnes.

The crew of the *Vachon* regularly used the tow-abort mechanism to release the tow line when it was under reduced tension, which gave the impression that the tow-abort mechanism was functioning properly. However, under the repeated pounding of the mechanical linkage, the seating plates had become recessed. At the time of the occurrence, the linkage was resting below its normal horizontal position. This meant that the pneumatic cylinder was unable to push the mechanical linkage upward in order to release the tow hook when the tow line was under full tension.

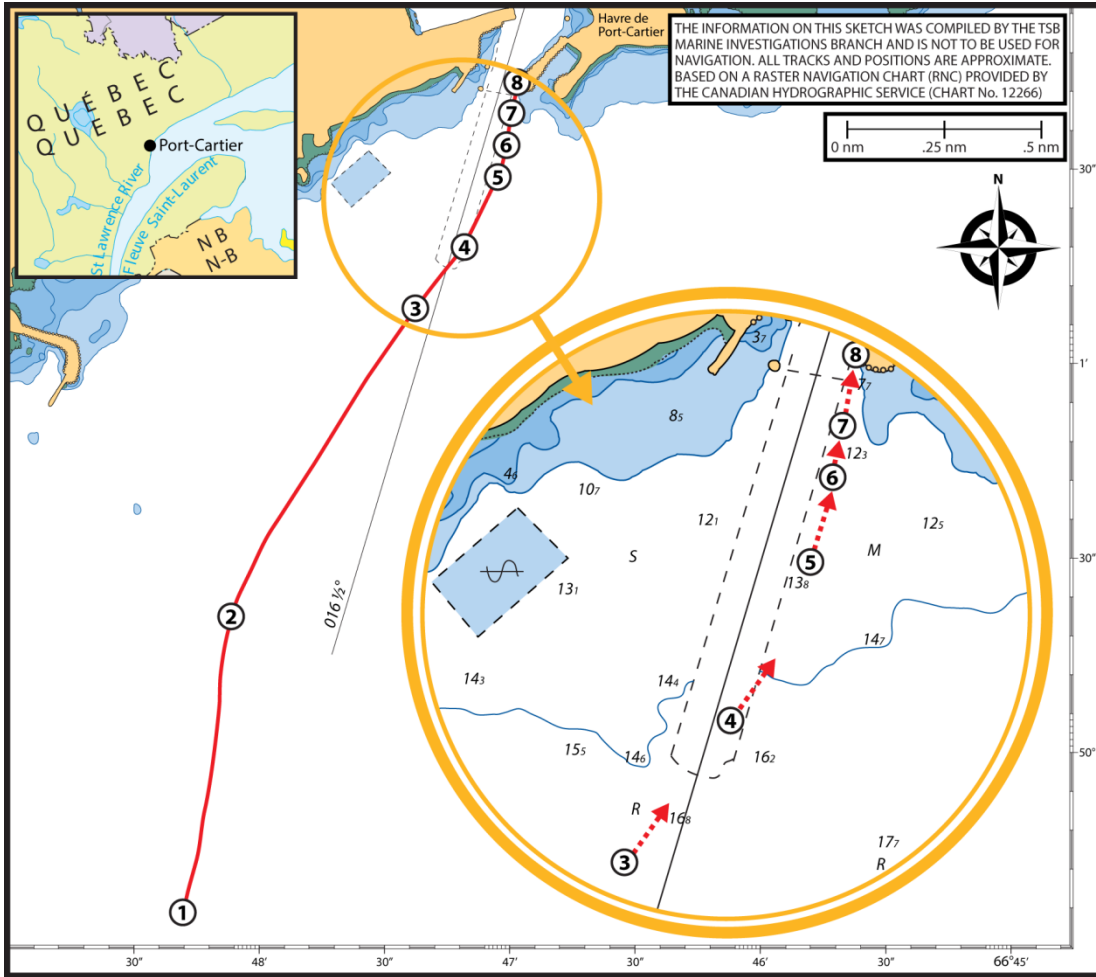
Appendix A – Area of occurrence

Once both tugs were secured, the *Orient Crusader* continued to proceed toward the port entrance. At 2027, the vessel was on a heading of 018°T⁴ at a speed of 4 knots, but its course made good (CMG) was 035°T due to the effect of the prevailing current. The vessel's position was approximately 40 m east of the recommended track indicated by the range lights, and the pilot was attempting to bring the vessel onto the range lights by altering course. By 2030, the vessel's heading was 005°T, its CMG was 019°T, and its speed was 3.7 knots. Its position was then approximately 90 m east of the recommended track, and outside the approach channel.

After taking over the con, the pilot navigated primarily by using visual cues to align the vessel on the recommended track, which was indicated by range lights. The pilot also visually referenced the cribs at the entrance to the harbour. Shortly after the tugs made fast, with the *Vachon* secured forward and the *Brochu* aft, the vessels advanced toward the harbour entrance, but were set east of the recommended track by the influence of the tidal current.

The pilot was aware of the ebbing tide and attempted to counteract it through course alterations and the use of the forward tug. However, the pilot did not fully appreciate the strength of the current and, therefore, the corrective actions were inadequate. As well, the monitoring by the *Orient Crusader's* bridge team did not identify the developing unsafe situation with respect to the *Vachon's* proximity to the breakwater.

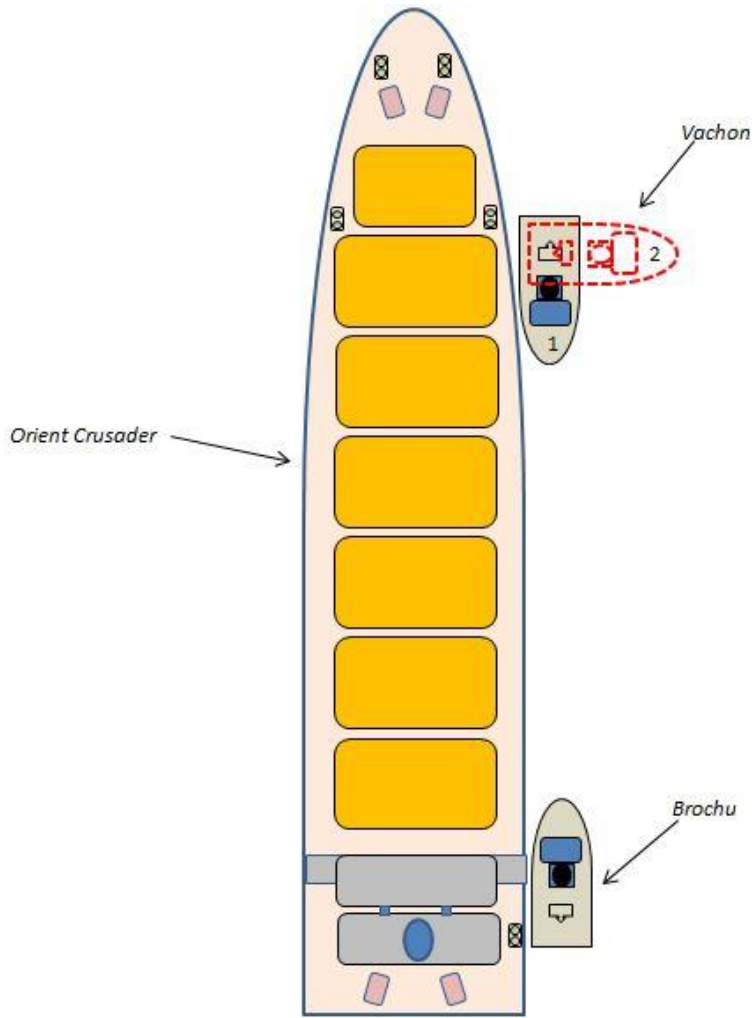
Appendix B – Position of tugs relative to vessel

At approximately 2032, the pilot ordered the *Vachon's* master to "push 6"⁵ to assist the vessel in returning to the recommended track. The pilot issued this order in French; subsequent communications with the 2 tug masters were also conducted in French. The *Vachon's* master manoeuvred the tug stern first and perpendicular to the *Orient Crusader's* starboard side. As

the available sea room was diminishing and push 6 was not sufficient to return the vessel to its track, the master applied push 8, and then push 10.

By 2033, the bow of the *Orient Crusader* was abeam of the breakwater. The master on the *Vachon* advised the pilot that he might have to release the tow line because of the tug's proximity to the breakwater. When it became apparent that the *Vachon* would not clear the breakwater, the master repositioned the *Vachon* so that its bow was once again pointing toward the stern of the *Orient Crusader*. He then activated the tow-abort mechanism to release the tow line, which was under full tension, but the tow line did not release. At approximately 2035, the *Vachon*'s port side struck the breakwater. Shortly after, the tension on the tow line decreased, allowing the tow line to release.
