Effect of Snow and Ice on Exterior Ramp Navigation by Wheelchair Users

Research Highlight

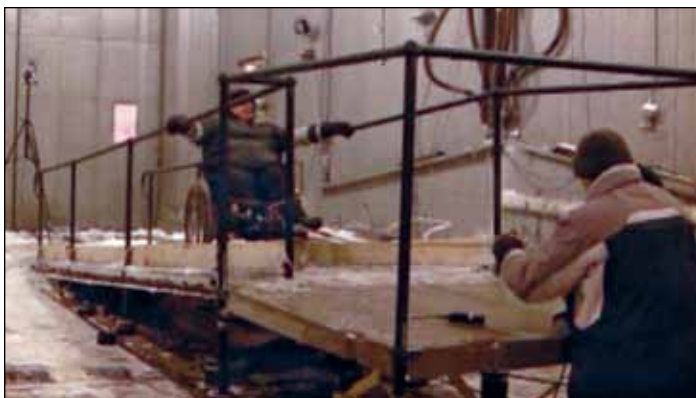
Figure 1 Ramp ascent on ice-grit using handrails

Even with sufficient grit, the more active subjects frequently had wheel slip issues during ascent at the 1:10 and 1:12 slopes (that is, stronger propulsive motion surpasses wheel-ice-grit friction). These subjects typically used a two-handrail pull approach to reinitiate motion and then reverted to standard propulsion. Recommendations could be made to use two-handrail propulsion under ice conditions since friction issues are resolved (that is, no propulsive force on

- For ice-grit ramp navigation, two-handrail propulsion is a preferred strategy, as it enhances trajectory control and reduces the potential for wheel slip problems.

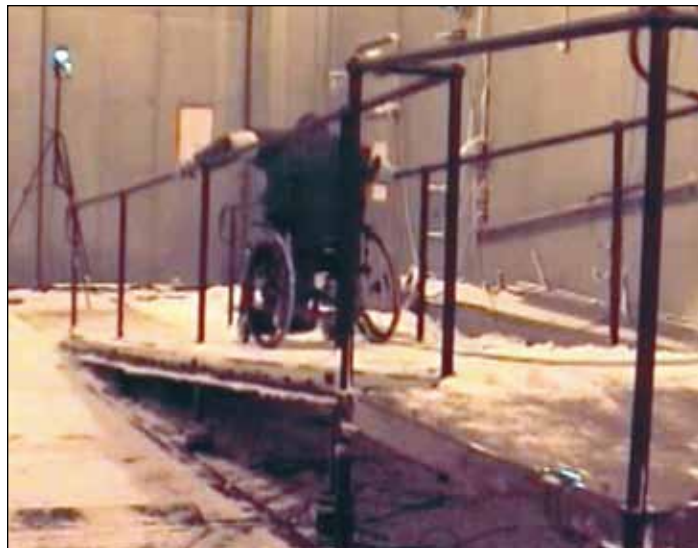
Figure 2 Backwards ramp ascent

One subject successfully ascended the ramp backwards, at all grades, by reaching back and pushing on both handrails. Since this subject was at a moderate functional level, the backwards strategy could be applicable for most people who manually propel their wheelchair in winter. The shoulder and trunk ranges of motion were also typical. More research on backwards ascent is warranted to verify how this approach can be used by lower-functioning wheelchair users and to determine if wheelchair and environmental issues exist when extended to a larger population.

- Backwards ramp ascent for snow conditions should be considered for people with sufficient shoulder and trunk ranges of motion, although further research should be performed to verify that the successful outcomes can be generalized beyond the single subject results in this study.
