RAILWAY INVESTIGATION REPORT

R01H0005

DERAILMENT

OTTAWA VALLEY RAILWAY

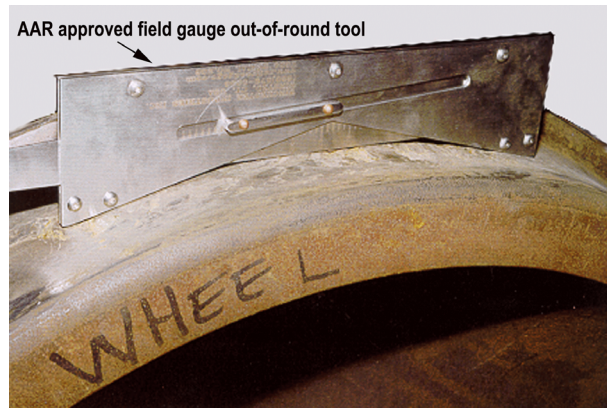
The purpose of safety inspections, performed by a certified car inspector, is to ensure that cars are deemed reasonably safe prior to allowing them to proceed down the track. During a safety inspection, each component of a car is examined and checked with measuring devices and gauges, when required. Defects such as shells or spalls can be identified visually; however, when they are healed (when metal flows into the spall cavities), they can only be identified by WILD systems. The detection of out-of-round wheels requires precise measurement at three locations using an out-of-round gauge (see Photo 1), or the use of WILD systems.

Photo 1. Measurement of out-of-round
