RAILWAY INVESTIGATION REPORT

R01M0024

MAIN TRACK DERAILMENT

VIA RAIL CANADA INC.

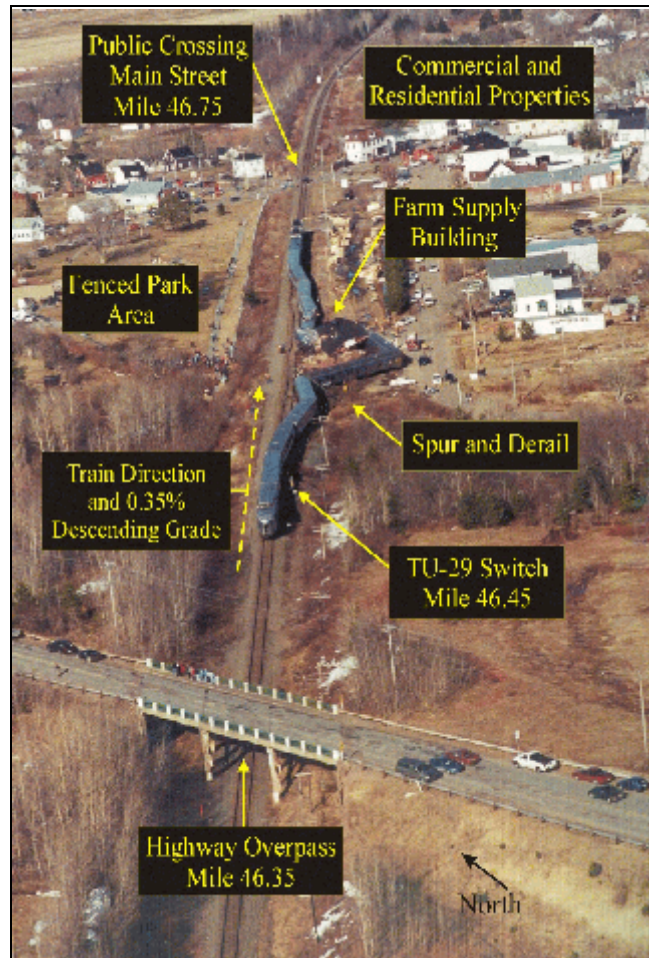
The derailment occurred between a highway overpass located at Mile 46.35 and a public crossing (equipped with flashing light signals and bell) located at Mile 46.75 (Figure 6). Although the train movement was designated as westward, in this location the track infrastructure was oriented north/south. The track was tangent on a 0.35 per cent descending grade. At Mile 46.45, there was a switch for an industrial track (TU-29). The industrial track was equipped with a derail which protected the main track from unintentional movements of rolling stock. There was a fenced park area to the west side of the tracks, and a mix of commercial and residential properties to the east side of the main track. The last intermediate signal (identified as H443) before the TU-29 switch was located at Mile 44.3. At that location, there was also a wayside inspection system (WIS).

When the derailed train came to rest, the TU-29 switch stand handle was observed to be raised and sitting on top of the switch stand table and the switch points were open.

Figure 6 - Aerial view of the occurrence site as viewed in the direction of train travel.

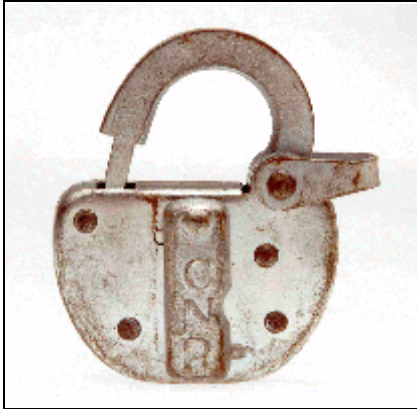
The switch stand was equipped with a standard CN switch lock (Figure 9). The clasp mechanism was broken and the switch lock was hanging loosely, suspended by the chain that affixes the lock to the switch stand. The lock had numerous dents and deformations (Figure 10).

Figure 9 - New standard switch lock.

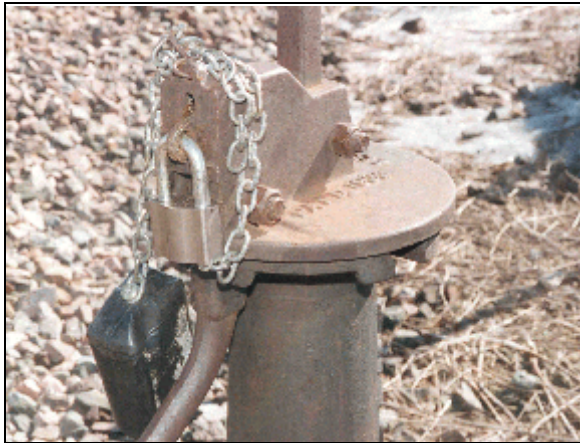
Maintenance personnel adjust switch points so that they are tight to the stock rail when set in the normal (closed) position. When the switch handle is fully rotated then lowered into its retaining slot and locked (Figure 12), the switch points apply a compressive force against the stock rail. Because the switch points are sitting on lubricated flat steel plates, as soon as the switch handle is unlocked and raised out of the slot, the force is released and the switch point generally moves away from the stock rail, opening the switch a slight amount. An examination of the occurrence switch stand revealed that the sole action of raising the switch handle in its slot vertically to the level of the table (Figure 13) was enough to cause the switch points to open approximately 1/4 inch.

Figure 12 - Switch handle fully lowered into retaining slot and locked.

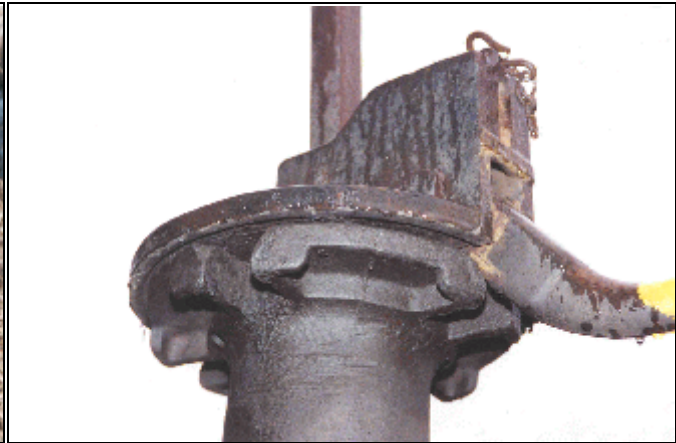
Figure 13 - Underside of switch stand showing table, retaining slots, and raised handle.

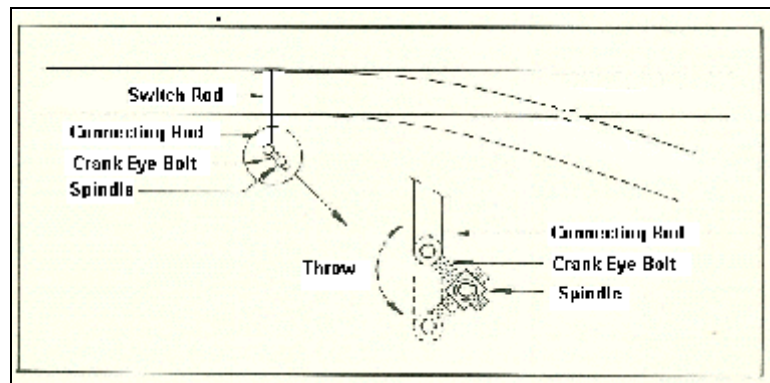
The switch target and tip assembly is directly affixed to the switch stand mast. The switch stand mast is linked to a spindle and switch handle (Figure 14). Therefore, there is a direct relationship between the lateral movement of the switch handle and the change in aspect of the switch target and mast. As the mast is rotated 90 degrees to move the switch points from the normal to the reverse position, the target attached to the mast and spindle moves to the same degree. The design of the switch stands and their associated targets dates from the early 1930s.

Figure 14 - Spindle, connecting rod and crank eye bolt.
