MARINE INVESTIGATION REPORT

M00W0005

STRIKING OF A BRIDGE

THE TUGBOAT "SEA CAP XII" AND

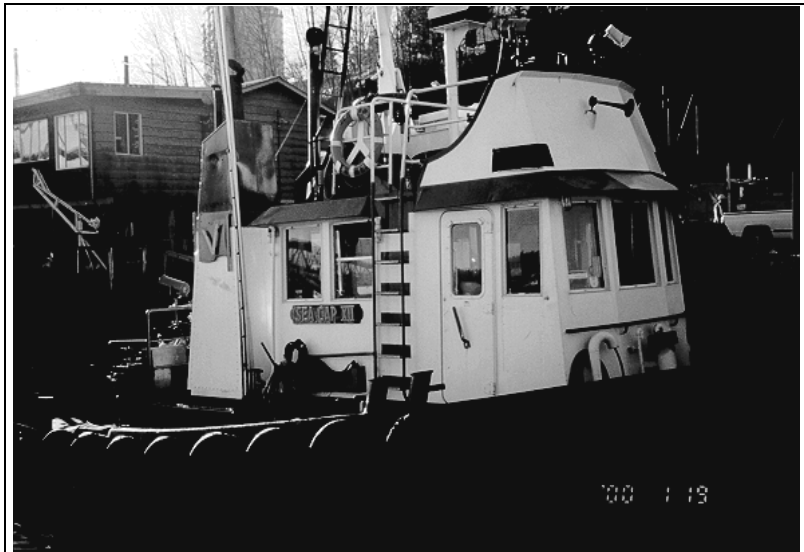
The “SEA CAP XII” is a small steel tug used mostly in the Fraser River, and occasionally for some light duties in the waters of the Strait of Georgia. It has two propellers in Kort Nozzles and four rudders connected by a bar. At the forward end of a midship deck-house is a control panel with navigation, steering and engine controls; at the after end is a galley. The deck-house, fitted with windows on all four sides, has an almost 360-degree view from the inside. The door leading to the stern of the tug is partially glassed. There are two funnels astern of the

deck-house. As these are offset from the centreline, the crew are able to observe the tow at all times.

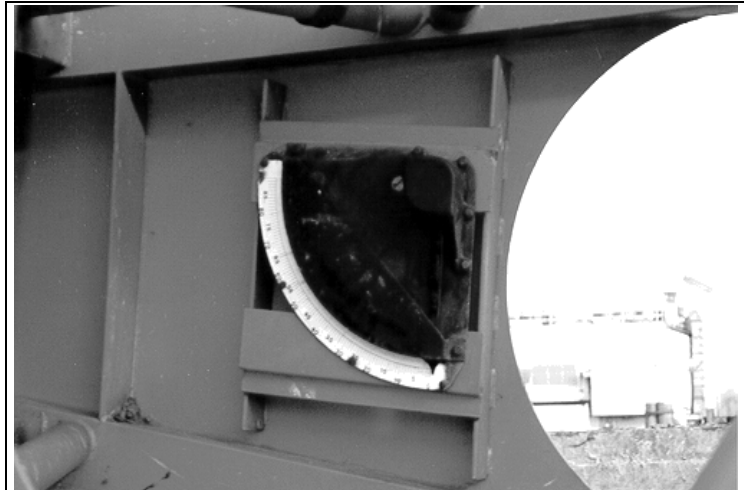
The crane operator was instructed by his supervisor to prepare the crane and barge for towing down the south arm of the Fraser River. The preparations included, *inter alia*, lifting the spuds, stowing them on top of the deck-house and securing the crane and boom. The supervisor gave no specific instructions as to the angle of the boom, and hence the height of its head.

Although an inclinometer was attached to the boom and visible from both the operator's position and from the barge's deck, neither the operator nor his supervisor considered the angle of inclination when the crane was being prepared for the transfer.
