MARINE INVESTIGATION REPORT  
M01C0033

TAKING ON WATER AND SINKING

AMPHIBIOUS VEHICLE *LADY DUCK*  
OTTAWA RIVER  
30 JUNE 2001

Report Number M01C0033

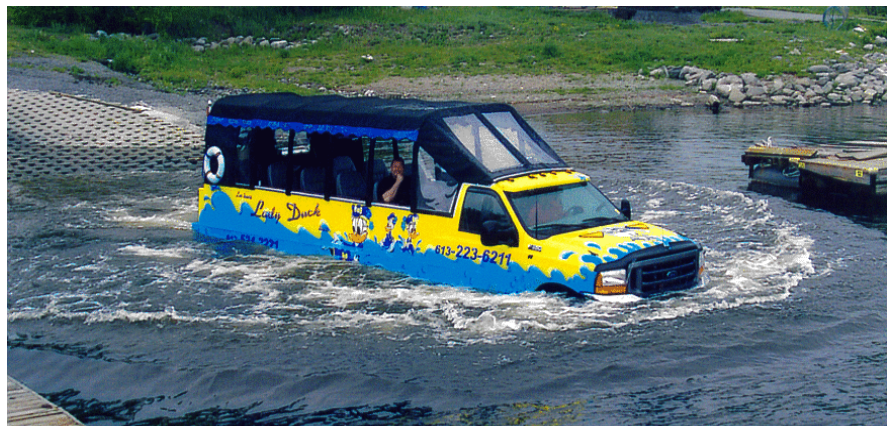
The *Lady Duck* is an amphibious vehicle arranged to carry up to 11 passengers on combined road and waterborne tours in the National Capital Region (NCR) and on the Ottawa River. The vehicle was developed and built by the owner and entered commercial service at the start of the tourist season in June 2001 (Photograph 1).

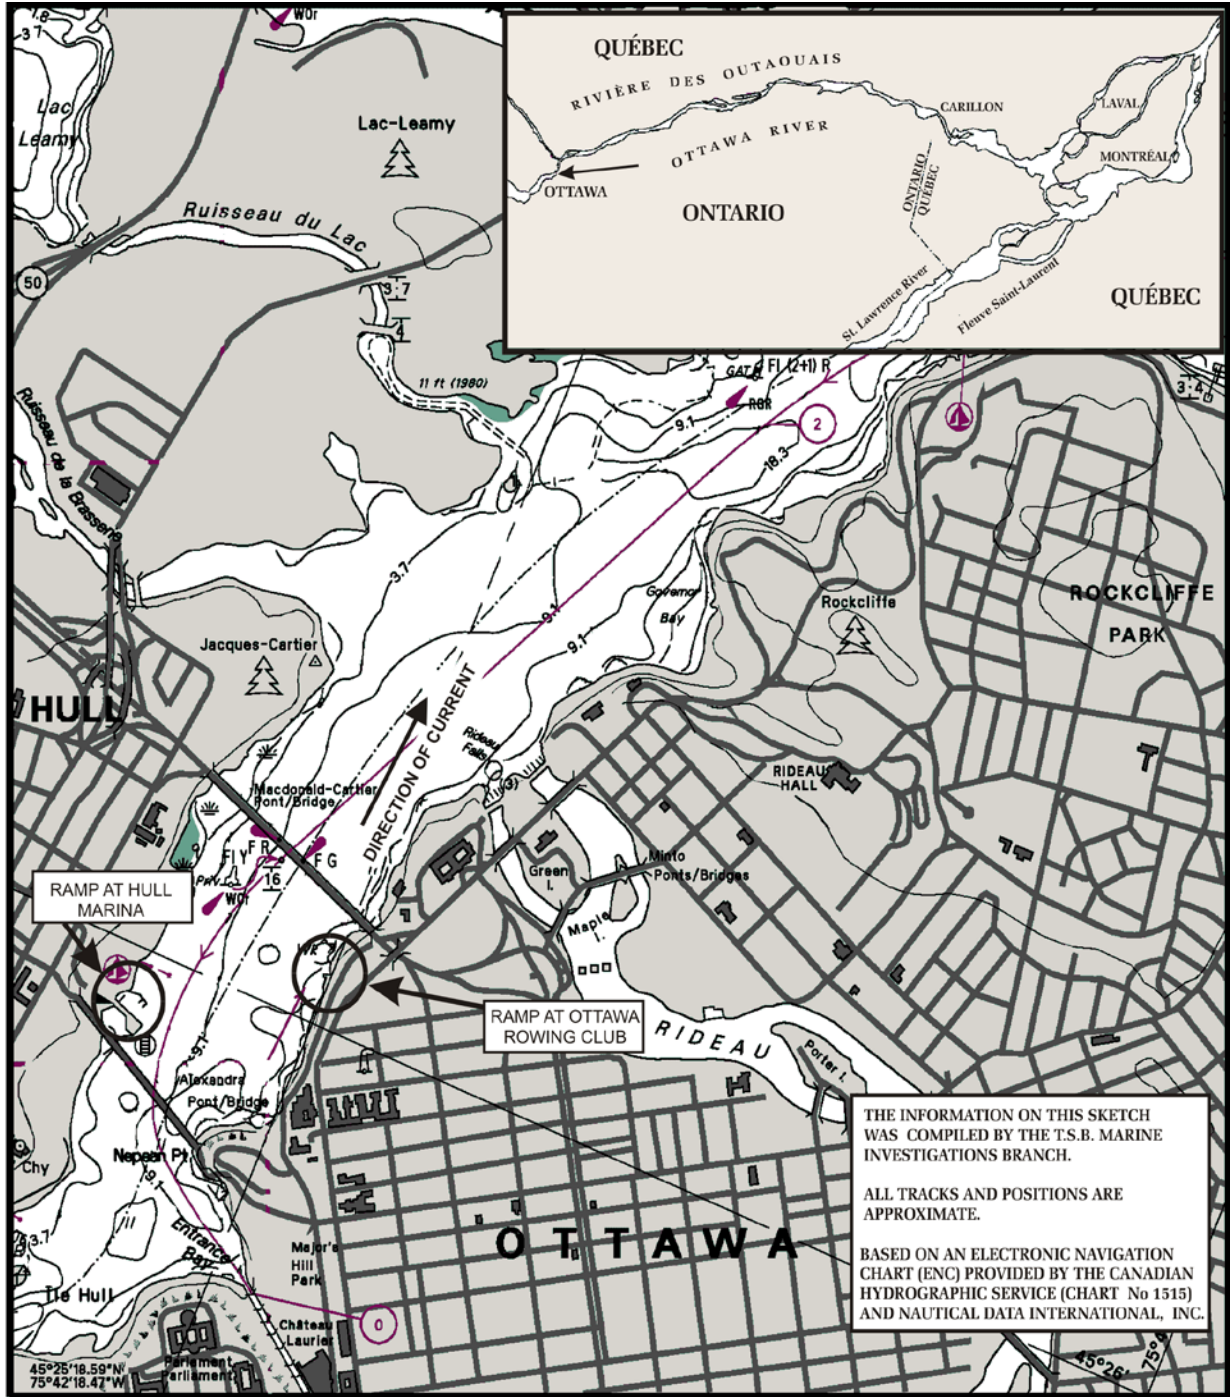
Appendix A: Sketch of Occurrence Area

When close to the ramp, GCU-480 was disengaged to enable the *Lady Duck* to make the left turn necessary to align the vehicle with the centreline of the ramp. However, because the damaged steering controls and the marked forward trim made manoeuvring difficult, the final approach was not directly in line with the ramp's central axis. The front right wheel became grounded on the left edge of the ramp, with the vehicle aligned some 45° to the left of the ramp axis.

The grounding effect at the front wheel slightly raised the right side of the vehicle, and floodwater in the hull surged and gravitated to the left. This transfer of weight caused the vehicle to suddenly heel to the left and ship water over that side. The OM quickly abandoned the vehicle before it downflooded, capsized, and sank alongside the ramp in 5.5 m of water. The vehicle finally came to rest on the river bottom at approximately 1110, lying on its right side, with the front end nearest the shore.
