MARINE INVESTIGATION REPORT

M04W0006

COLLISION

**BETWEEN THE ROLL-ON/ROLL-OFF
VEHICLE/PASSENGER FERRY *QUEEN OF SURREY*
AND ASSIST TUG *CHARLES H. CATES V*
HORSESHOE BAY, BRITISH COLUMBIA
11 JANUARY 2004**

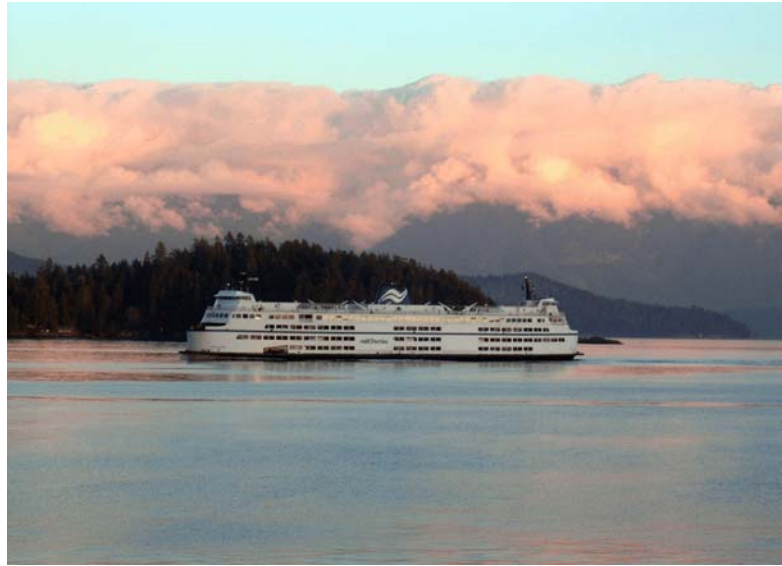
Photo 1. The *Queen of Surrey*

A steel rubbing strake extends around the vessel's main deck and protrudes approximately 2.7 m at each end and approximately 0.46 m at the sides.

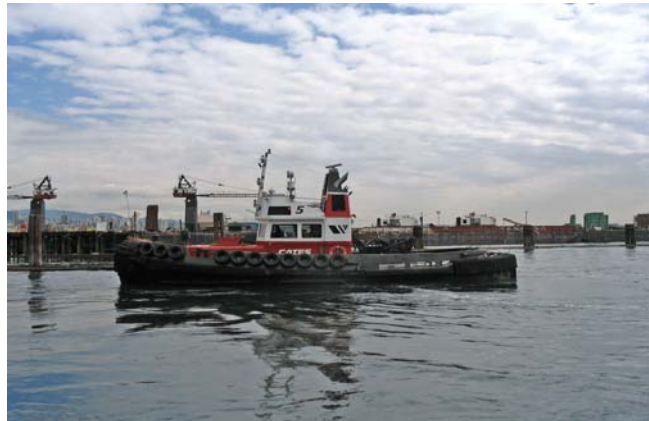
Photo 2. The *Cates V*

The *Cates V* suffered extensive damage to its superstructure, necessitating a complete rebuilding of its superstructure including all electric wiring, plumbing and fixtures.
