MARINE INVESTIGATION REPORT

M08W0189

CAPSIZING AND SUBSEQUENT SINKING

SMALL FISHING VESSEL *LOVE AND ANARCHY*

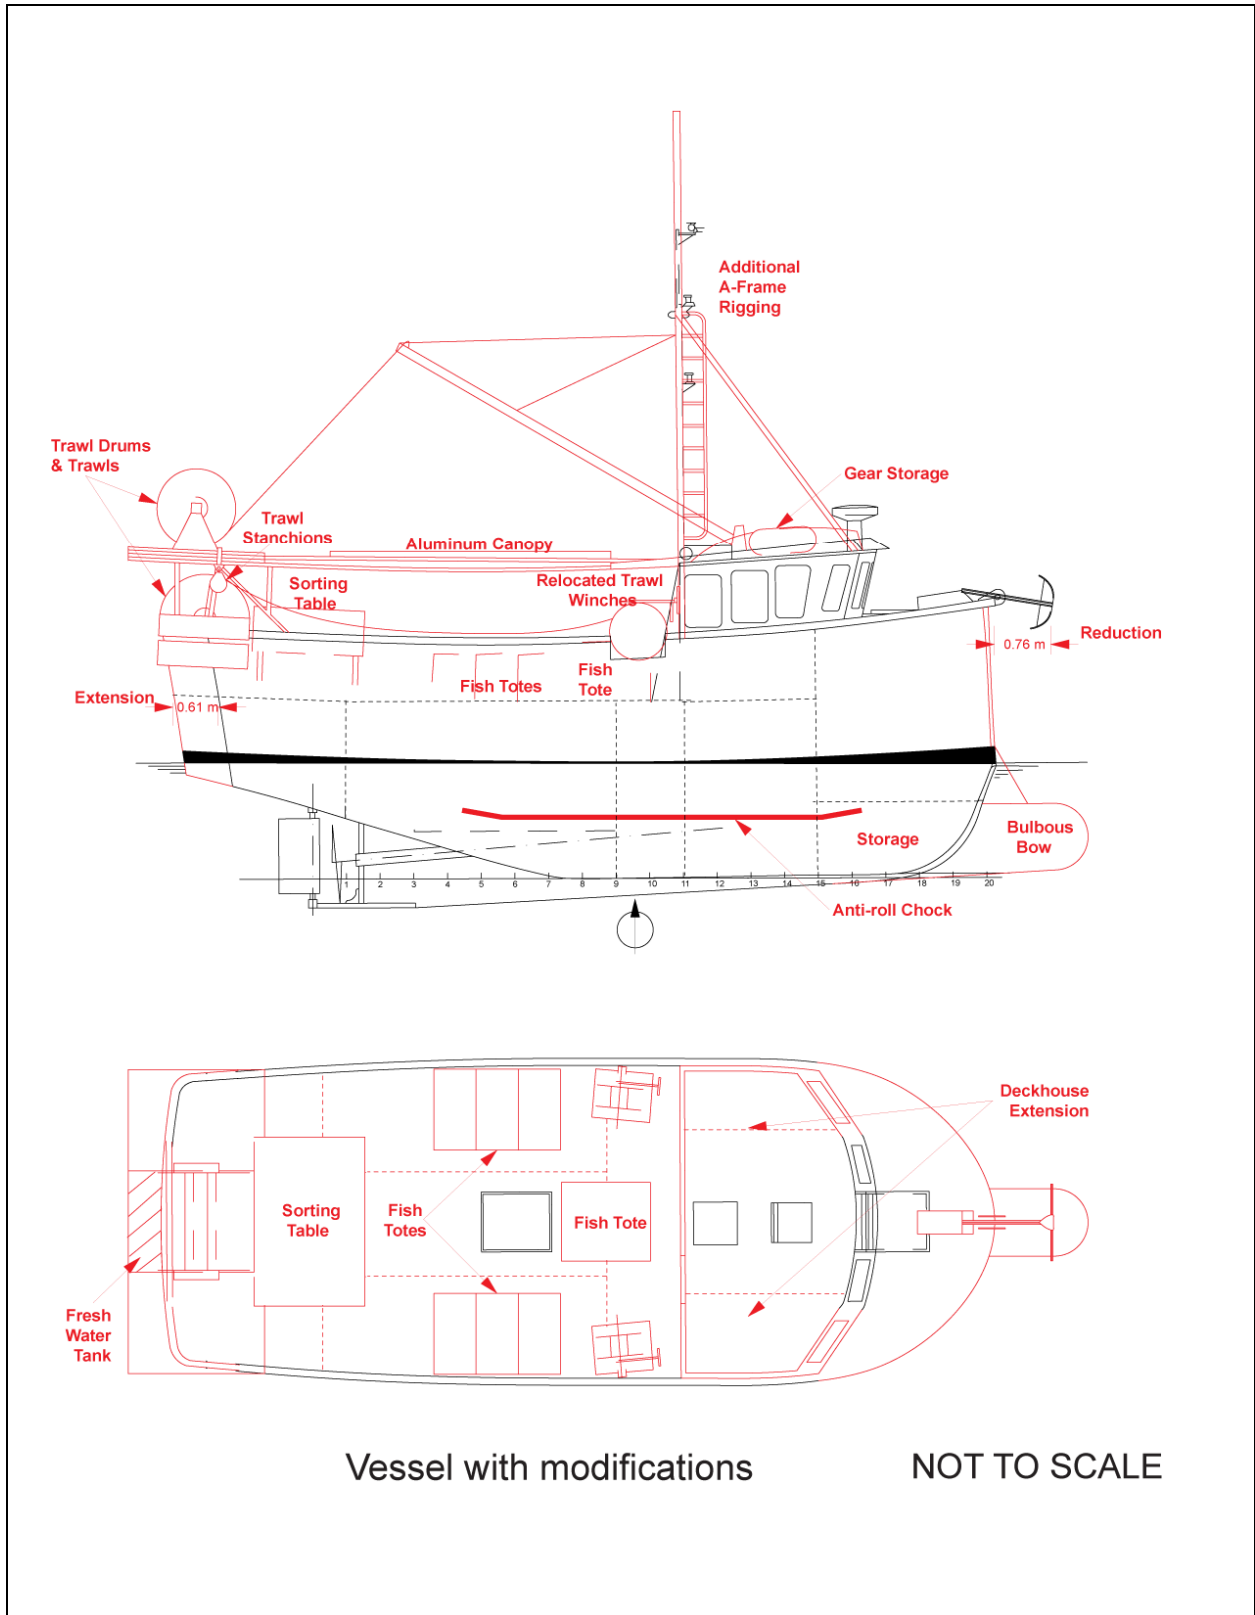
Appendix A-2 – Vessel General Arrangement

¹⁹ As noted earlier, an additional change was the widening of the deckhouse by 1.5 m.
