**MARINE INVESTIGATION REPORT  
M10F0003**

**KNOCKDOWN AND CAPSIZING**

**SAIL TRAINING YACHT *CONCORDIA*  
300 MILES SSE OFF RIO DE JANEIRO, BRAZIL  
17 FEBRUARY 2010**

Report Number M10F0003

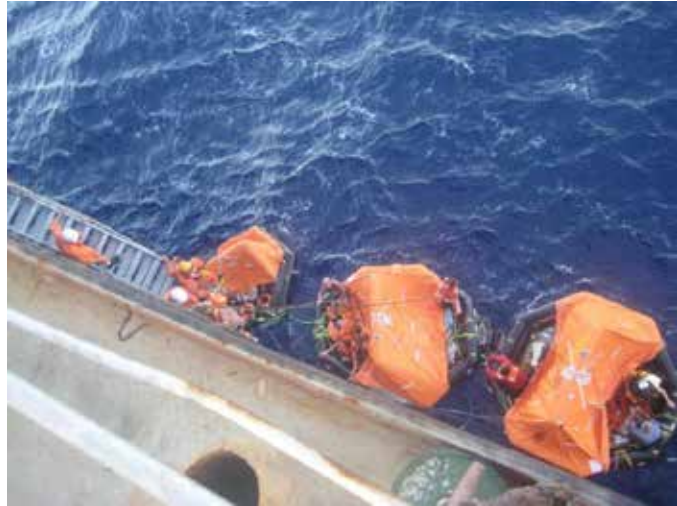
**Photo 2.** Liferafts alongside *Hokuetsu Delight*

One of the 4 rafts was retrieved from the water. This raft and its associated equipment were not available for examination during the investigation.

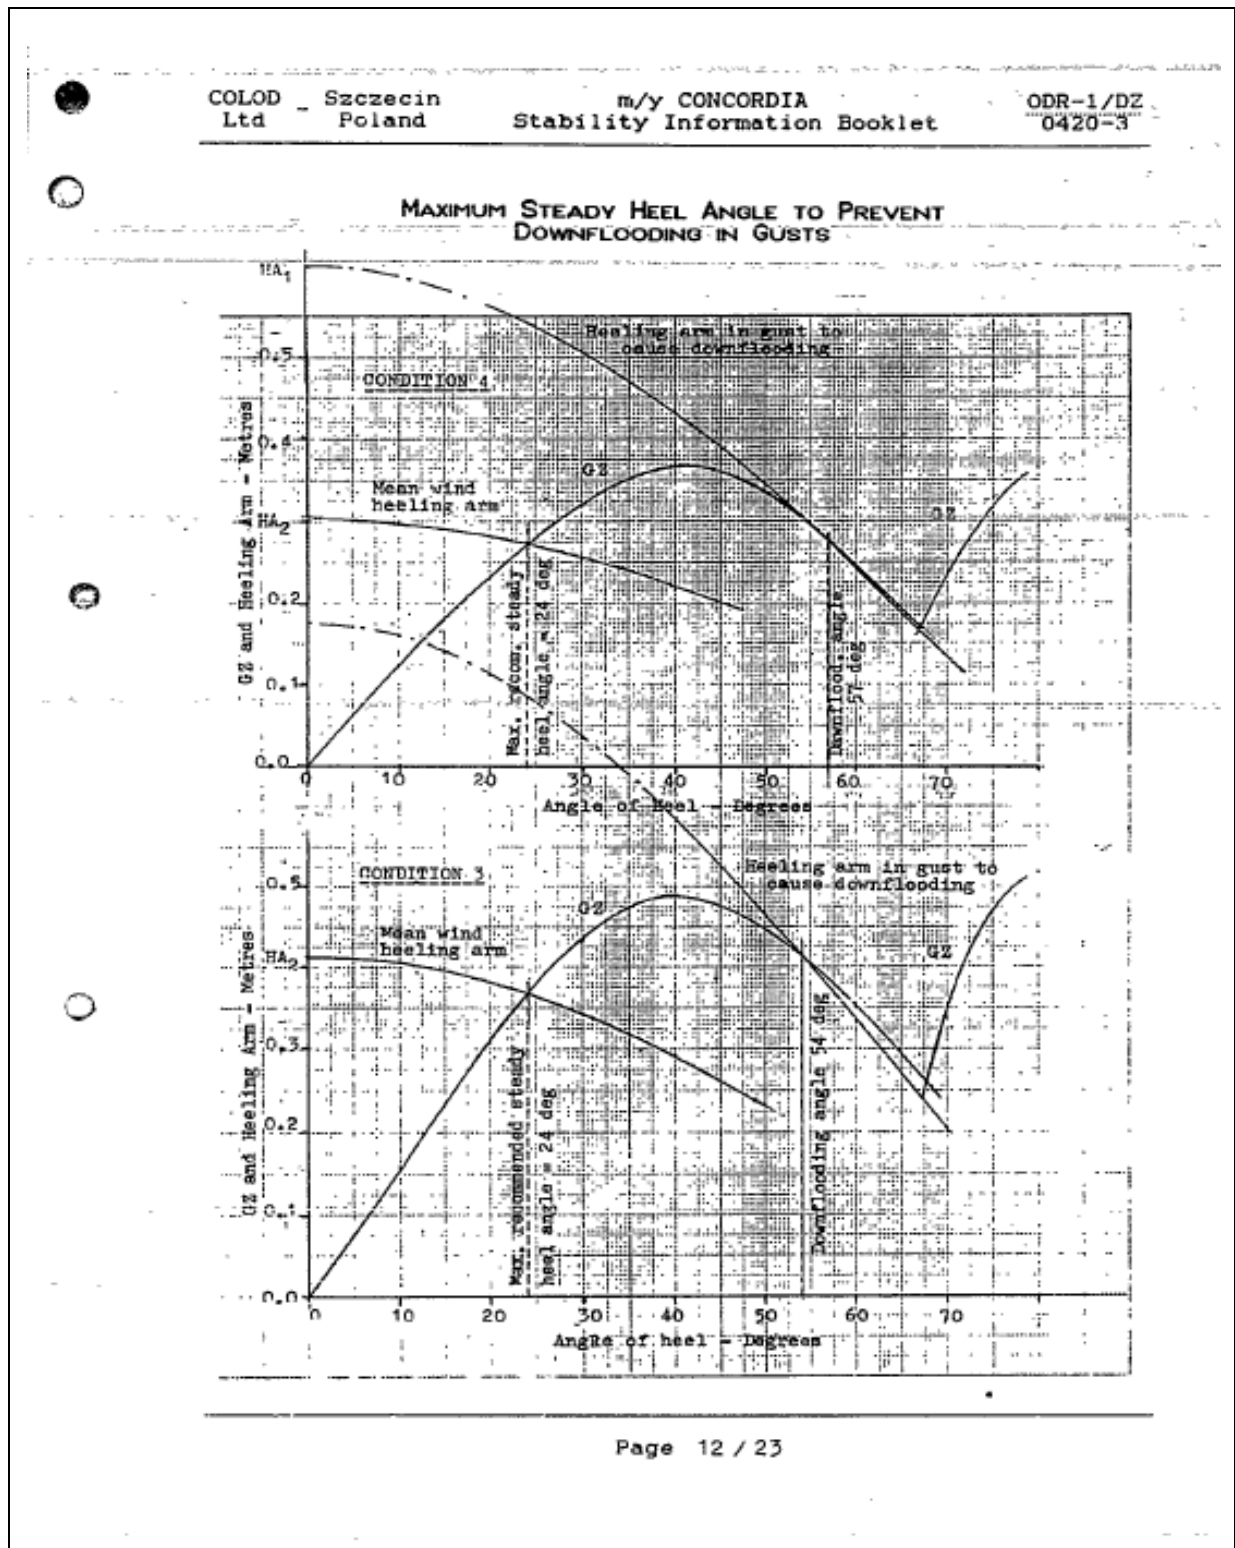
# Appendix F – Maximum Steady Heel Angle to Prevent Downflooding in Gusts and Squalls

Curves of maximum steady heel angle indicate the range of mean or steady heel angles beyond which the vessel will suffer downflooding in the event of a squall. Operation of the vessel in cyclonic conditions particularly in the hours of darkness, where severe squalls are imminent requires the recommended maximum steady heel angle to be reduced depending on the mean apparent wind speed in accordance with the curves presented above.

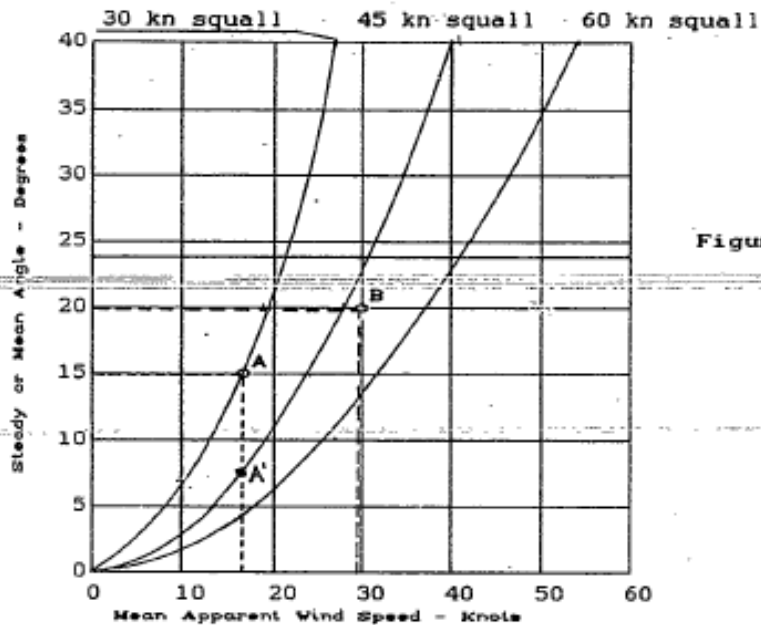
Figure 1

*Example A* The yacht is reaching, with a steady apparent wind speed of 16 knots. The mean heel angle is 15 degrees. Forecasts and visible cumulo-nimbus clouds suggest squalls may be imminent. By plotting the heel angle and wind speed (point A in Figure 1) the indication is that the vessel will be in danger of heeling to the downflooding angle in squalls of 30 knots. In order to increase safety from downflooding, say, to withstand squalls of up to 45 knots, sails should be handed or reefed to reduce the mean heel angle to 7 degrees (point A' in Figure 1) or less.

*Example B* The yacht is beating in gusty conditions with a mean apparent wind speed of 30 knots. The mean heel angle is 20 degrees. No squalls are expected. The heel angle is significantly less than 24 degrees, the maximum recommended steady heel angle, and there is therefore a good safety margin against downflooding in a strong gust. Plotting these values of wind speed and heel angle (point B in Figure 1) also indicates that the vessel would not be vulnerable to downflooding in a squall unless it resulted in a wind speed in excess of about 50 knots. There is thus no need to reduce sail area on the grounds of stability.

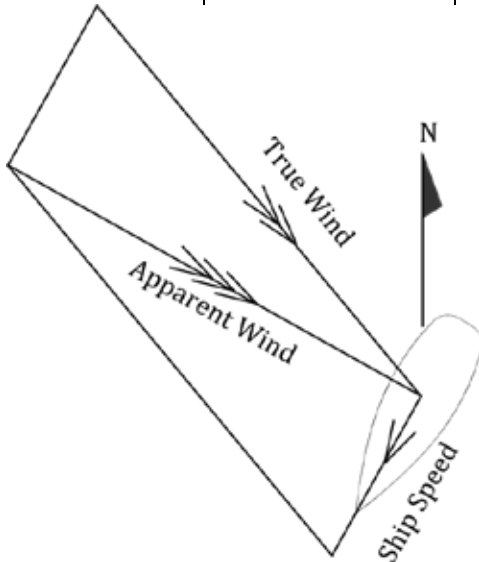
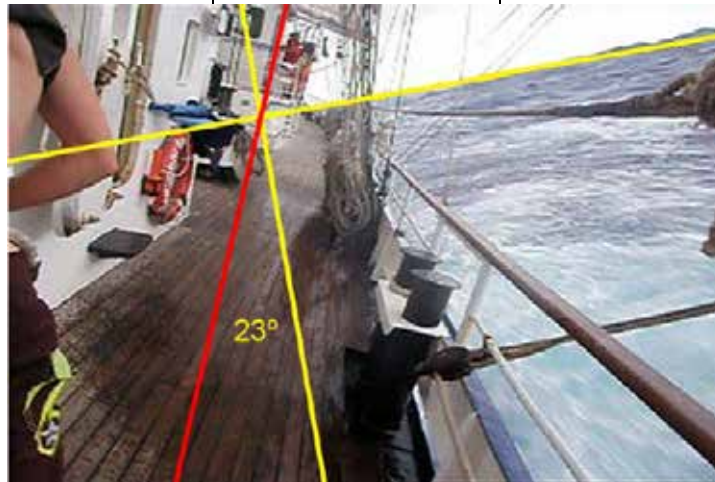
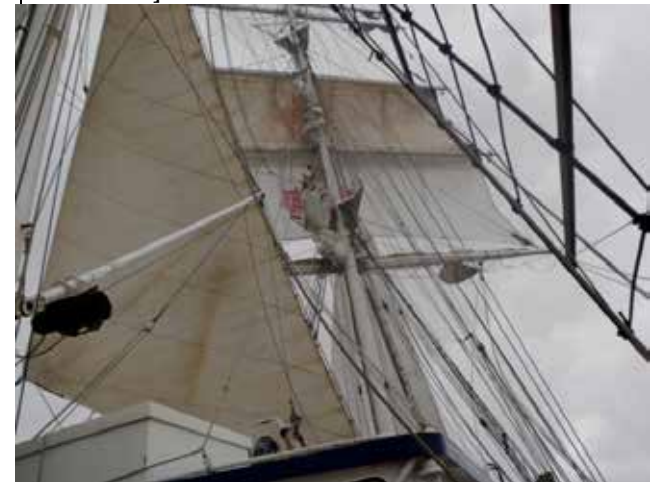
Time Period (Approx)	Ship Speed /Heading	True Wind	Apparent Wind	Heel	Notes
1420  2 to 3 minutes - Student takes video (57 sec) showing conditions on deck and some still photos	Approximation: 9 knots at 210°	Approximation: 25 knots at 320°	Investigation Info: 23 knots  Derived Using Approximations for Ship and True Wind Info: 23.5 knots at 88.9°  * See notes	Investigation Info: 23° min  Calculated range of apparent wind speed for this heel is 20 to 28 knots * See notes	<ul style="list-style-type: none"> <li>• Analysis of video footage determined that the minimum angle of inclination of the vessel which could be discerned from the video was 23°. [See photo, below]</li> <li>• Video shows inner jib with leading edge full but trailing edge flapping; likely due to blanketing effect of forestaysail. Main staysail and main also appear full, indicating a likely apparent wind angle at least at the beam or aft of that</li> <li>• Square sails full, indicating likely apparent wind angle at least at the beam or aft of that [see photo below]</li> </ul>

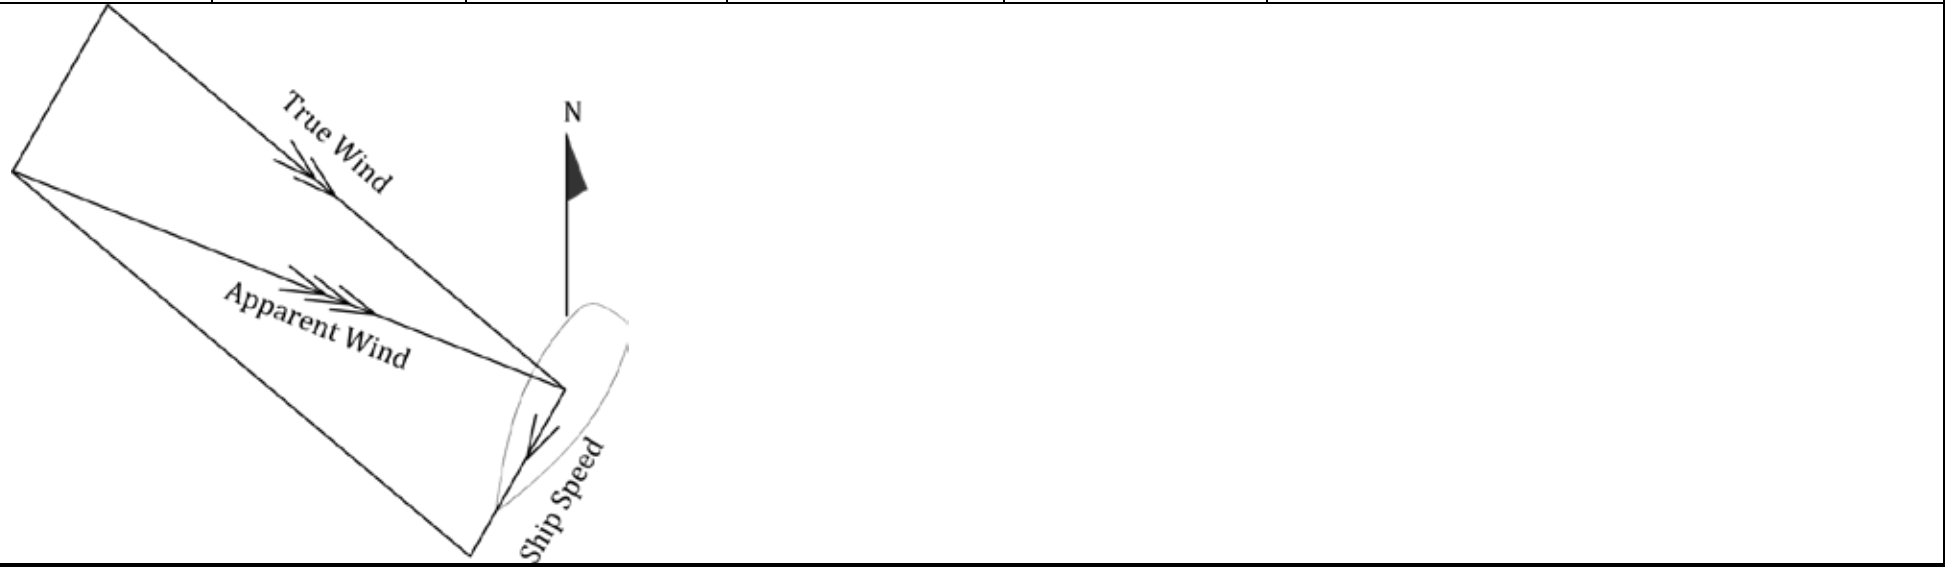
Time Period (Approx)	Ship Speed /Heading	True Wind	Apparent Wind	Heel	Notes
1423 Start of capsize	Approximation: 9 knots at 210°	Approximation: 28 knots at 310°	Investigation Info: Wind speed starts to increase (climbing to 27 knots) and apparent angle decreases  Derived Using Approximations for Ship and True Wind Info: 27.9 knots at 81.5°  * See notes.	Investigation Info: Vessel starts to heel; motion is essentially continuous  Calculated range of apparent wind speed for heel from 38° to 68° is 27 to 37 knots	<ul style="list-style-type: none"> <li>As vessel heels, port lookout moves to bridge door to express concern; at this point vessel would have been heeled to about 63.5° as bridge deck port side is just going underwater.</li> <li>Information obtained during the investigation indicated that winds did not reach a level that caused concern or made it impossible to remain standing upright on deck. Considering these factors and the calculations it is unlikely that the winds would have been much in excess of 40 knots.</li> <li>The 2/O observed the anemometer (30 knots from 120° to 150°) when the vessel was heeled by about 88°. It should be noted that the anemometer is not considered reliable at this angle and also that the vessel may have turned in response to the port helm.</li> </ul>
