MARINE INVESTIGATION REPORT
M15C0006

GROUNDING

SELF-DISCHARGING BULK CARRIER *ATLANTIC ERIE*
CHENAL DU HAVRE DE LA GRANDE ENTRÉE
ÎLES DE LA MADELEINE, QUEBEC
11 JANUARY 2015

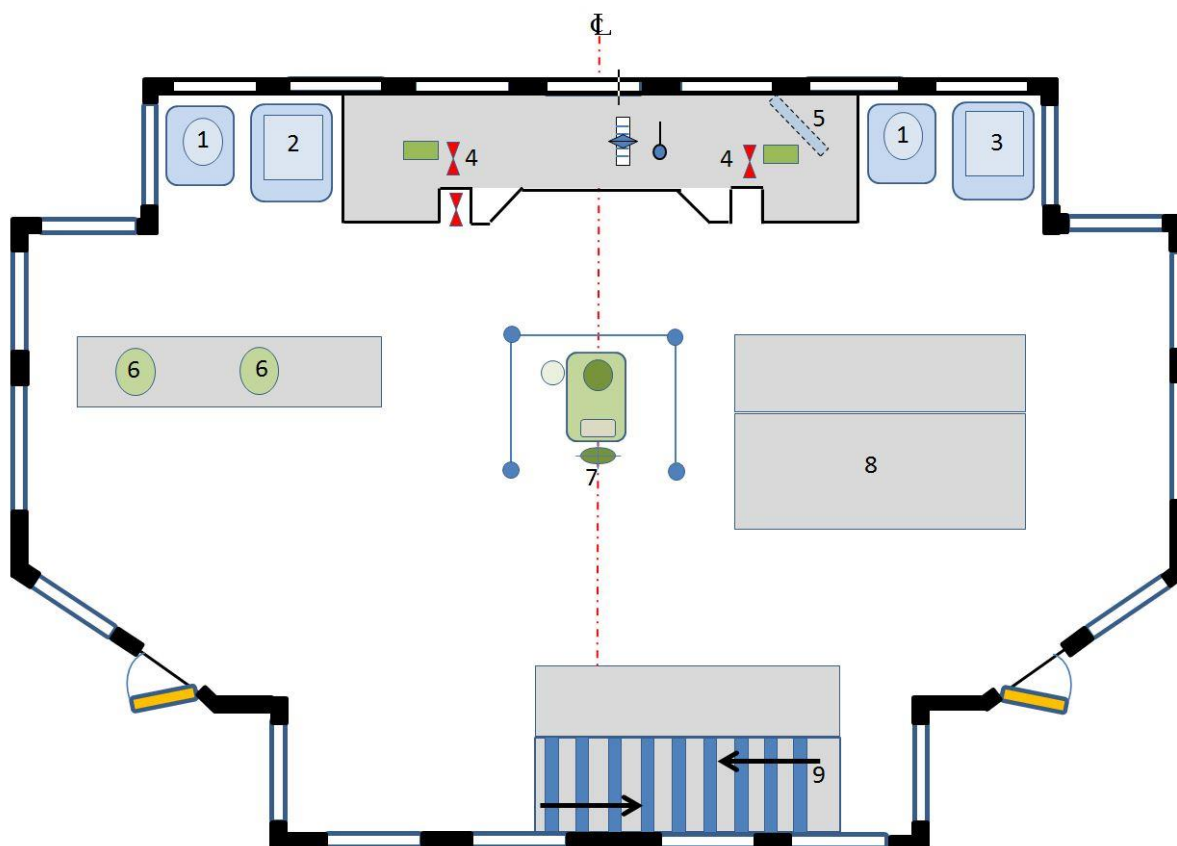
Appendix A – Bridge layout

The bridge is equipped with the required navigational equipment, including a 3-cm wavelength radar located right of the centre console and a 10 cm wavelength radar located left of it (Appendix A). Two gyrocompasses, a magnetic compass, a depth sounder, and 2 very high frequency (VHF) radiotelephones are also fitted on the bridge.

The vessel is equipped with a differential global positioning system (DGPS), as well as a 3D Navigator draft information system that can be used as an electronic charting system (ECS). The vessel's electronic chart precise integrated navigation system (ECPINS), which is also an ECS, is located to the left of the centre console. A repeater monitor for the ECPINS is mounted on the deckhead above the centre console. There was no voyage data recorder (VDR) installed on board, nor is there any regulatory requirement for vessels of this class constructed prior to 01 January 2012 to be fitted with a VDR or a simplified voyage data recorder (S-VDR).¹

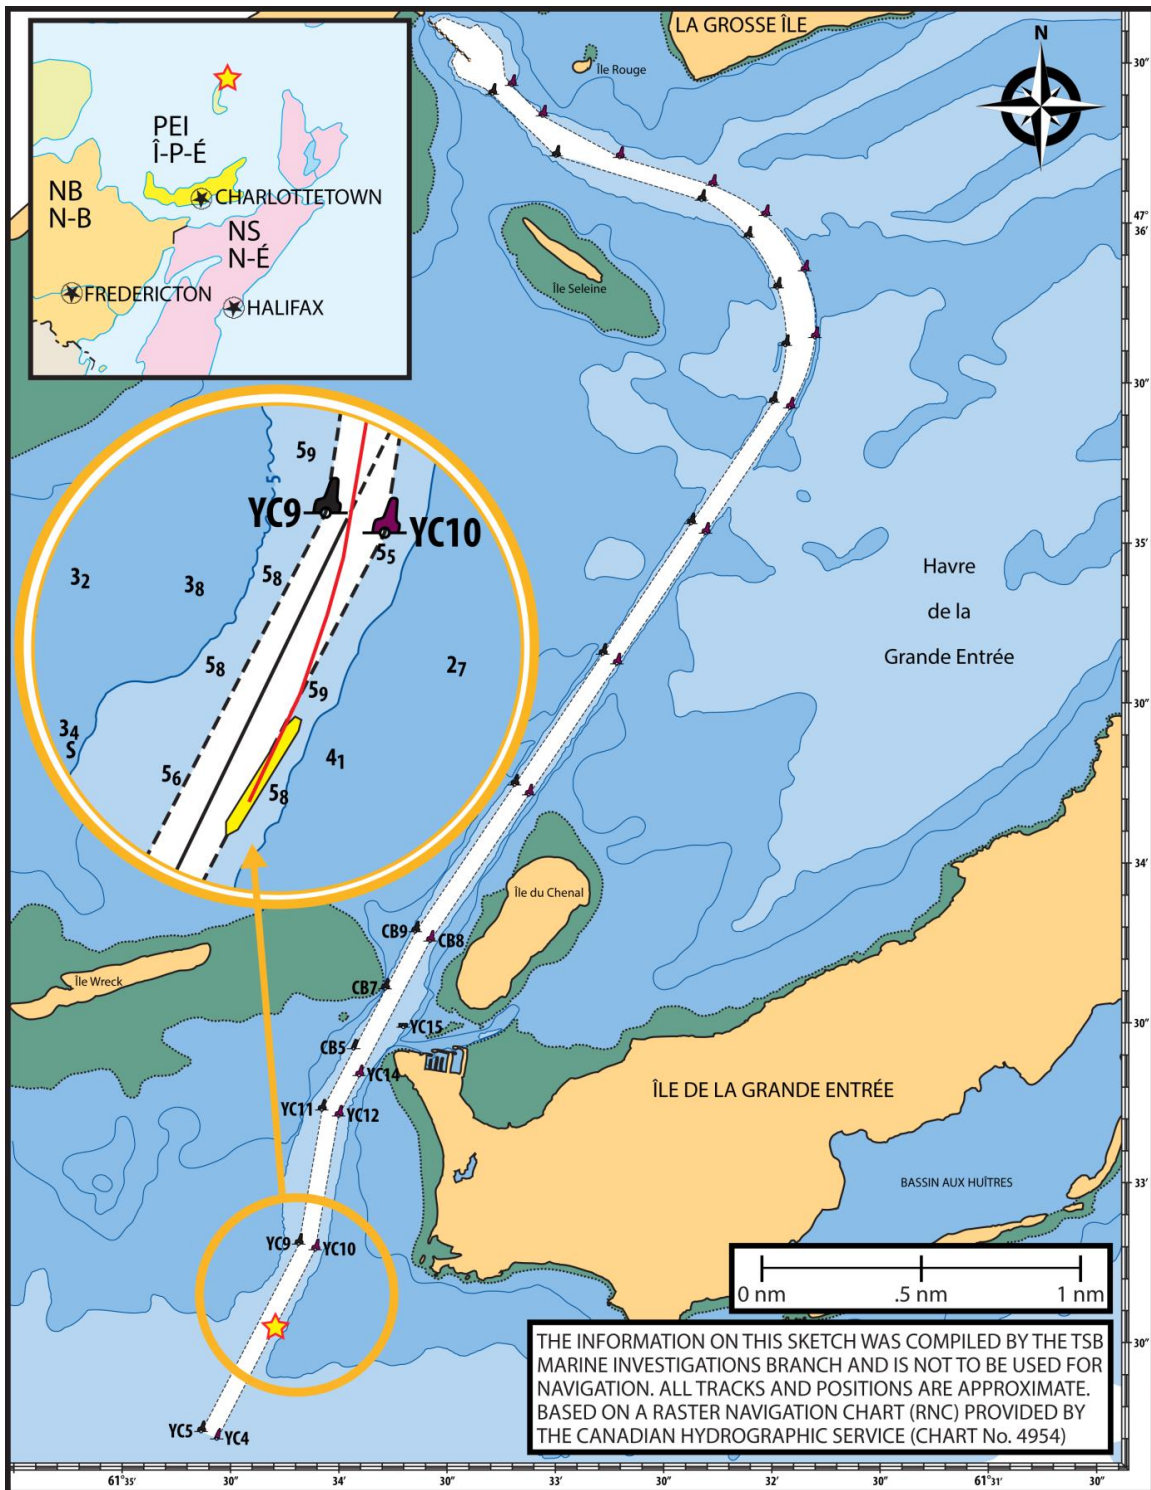
Appendix B – Area of the occurrence

Note: Three of the innermost buoys are not shown on this chart. The Canadian Coast Guard maintains buoys YC4, YC5, YC9, YC10, YC11, YC12, YC14, and YC15. The rest of the buoys are maintained by Mines Seleine.
