MARINE INVESTIGATION REPORT

M97N0073

THE FISHING VESSEL "RYANE & SISTERS"
GRAND BANKS OF NEWFOUNDLAND

26 MAY 1997

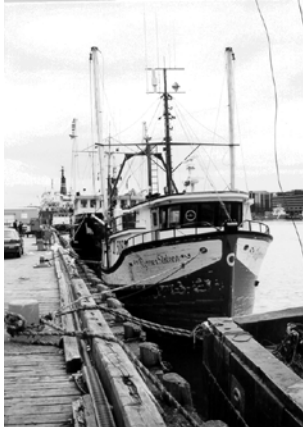
Photograph Number 1

The “RYANE & SISTERS” is an east coast Cape Island type wooden hulled vessel with the wheelhouse and accommodation forward and a partly sheltered work deck located aft over the fish hold (see Appendix A, Photo 1).
