MARINE INVESTIGATION REPORT
M00W0230

FATAL ACCIDENT

FISHING VESSEL – TRAWLER “STAR QUEEN”
FRASER RIVER, BRITISH COLUMBIA
6 SEPTEMBER 2000

Report Number M00W0230

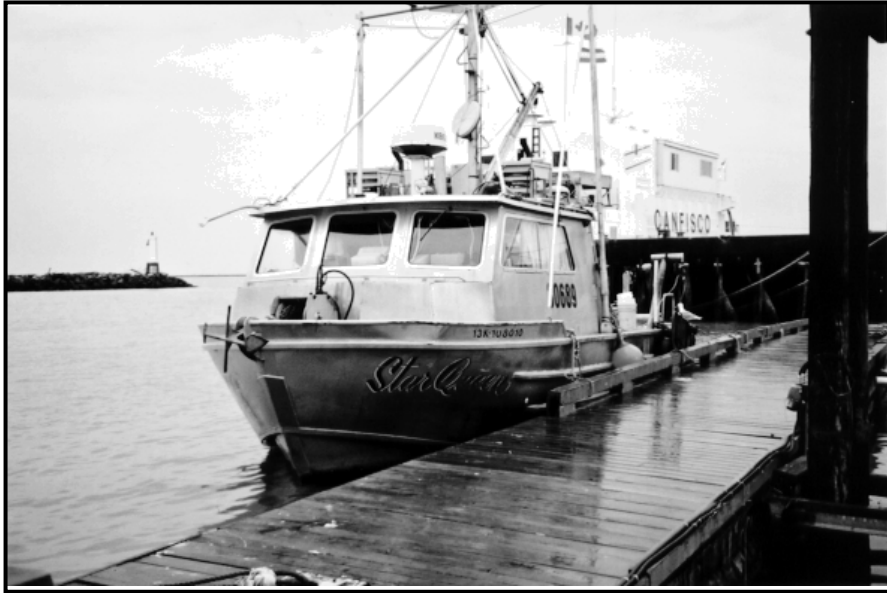
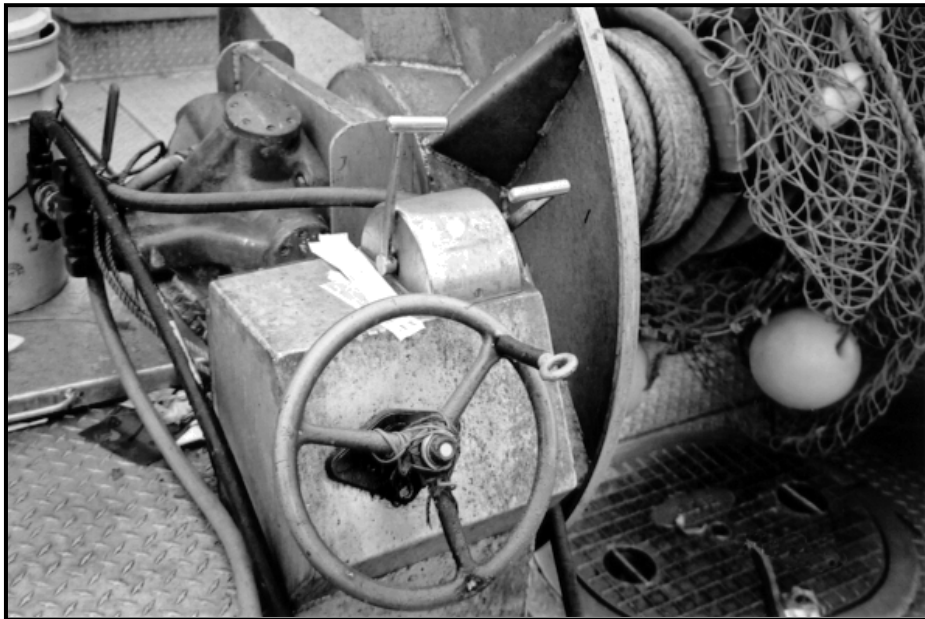
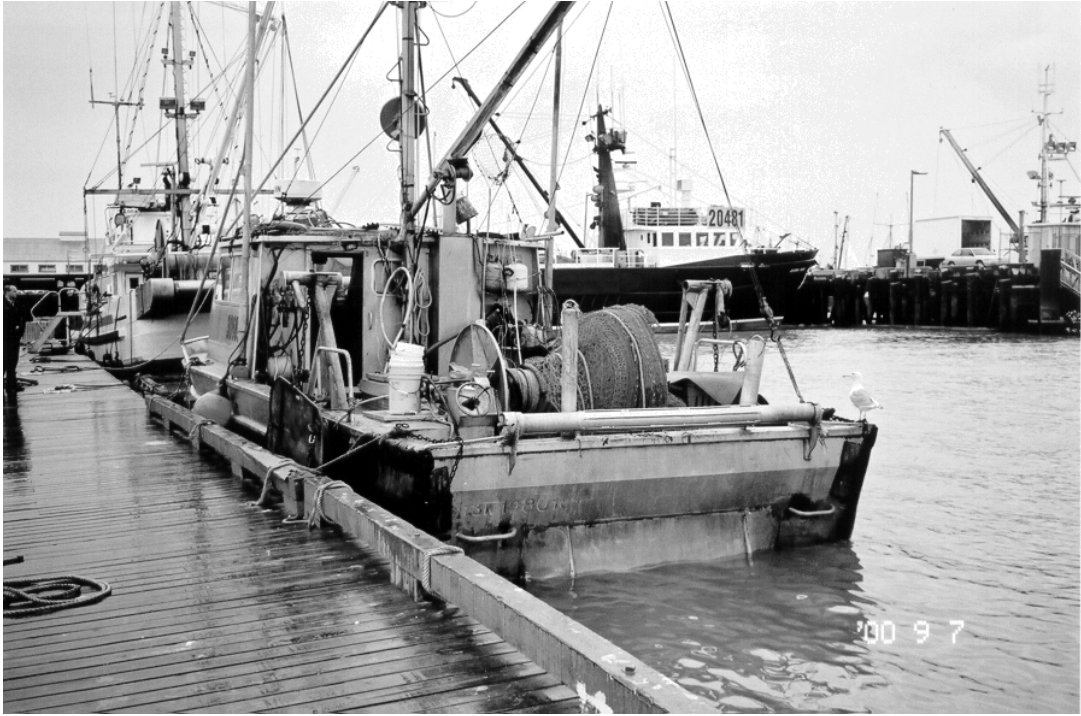
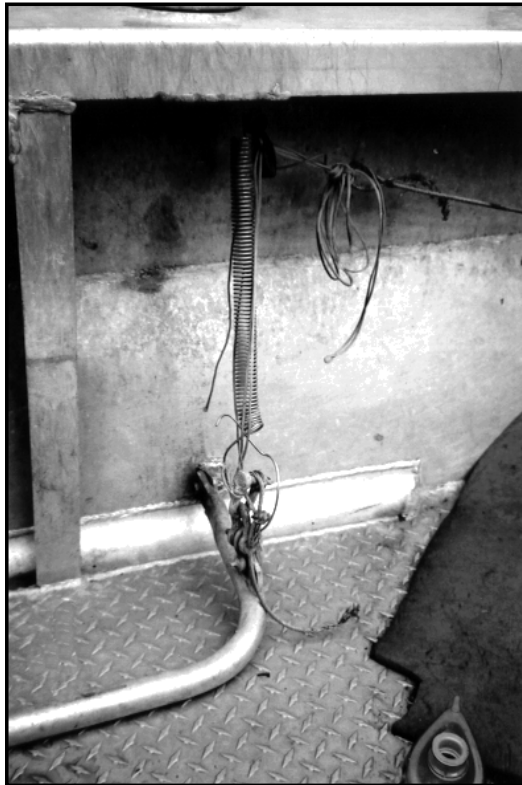
Appendix A – Photographs

The fishing gear consisted of a trawl net attached to a wire warp, which was in turn fixed securely to the winch drum. The condition of the wire warp was sub-standard because the lay of the wire had opened and loose strands were protruding. The fishing net had been paid out until the drum was most probably completely empty. The operator was wearing loose-fitting protective rain gear, and it is possible that he was standing in between the sides of the drum, preparing to guide the net as it was being hauled in. As the drum was turning, the sharp strands of wire probably caught his loose sleeve or jacket, and pulled him in.

Torn portions of his jacket were found entwined in between the turns of wire rope and the drum. Boots, hat, and the remainder of the jacket were found at various locations on the after deck.

The control valve was observed to be leaking and the working deck was found to be covered with hydraulic oil and was quite slippery. The operator was not wearing boots when he was found and it is possible that he had slipped on this oily surface and become entangled in the fish net as it was being reeled in. Since the hold-to-run-control had been disconnected (and also because he was working alone), once he had lost his footing, there was no way of stopping the winch.
