MARINE INVESTIGATION REPORT  
M01C0063

PERSONS OVERBOARD

WATER JET BOAT *SAUTE MOUTONS 14*  
NIAGARA RIVER GORGE, ONTARIO  
02 SEPTEMBER 2001

Report Number M01C0063

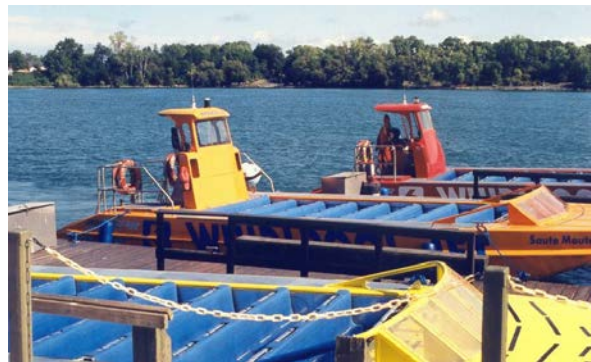
Seven rows of anti-shock, foam-cushioned and spring-dampened benches make up the passenger seating area. This area is fitted between moulded, compartmentalized buoyancy tanks, which also form part of the outer hull, sides and bottom. Immediately in front of each row of seating is a horizontal stainless steel support bar at arm's reach, grasped by the

passengers to assist them in remaining seated during the whitewater ride. There is no central aisle and crew members who need to walk forward from the steering station do so on the top surface of the 0.8 metres wide, side buoyancy tanks.
