MARINE INVESTIGATION REPORT

M02W0102

CAPSIZING

SMALL FISHING VESSEL *FRITZI-ANN*
NEAR KELSEY BAY, BRITISH COLUMBIA

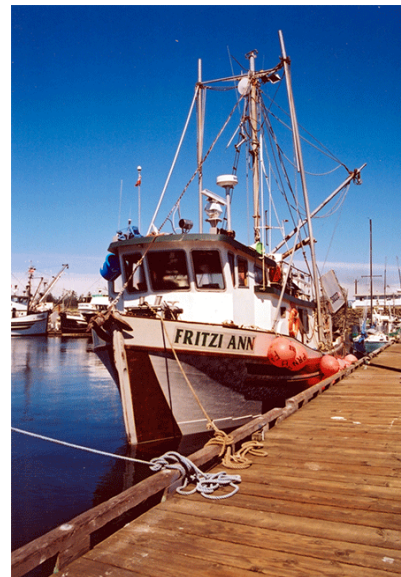
The *Fritzi-Ann* is a small wooden carvel-built fishing vessel of closed construction with a rounded bilge. The wheelhouse, crew accommodation and engine-room space are located forward of midships. An insulated fish hold, a small freezer compartment and the lazaret are located aft. The fish hold is divided into six sections by portable pen boards and it has a fibreglass weathertight hatch cover.

An aluminum platform, extending approximately 1.67 m aft of the extreme after end of the weather deck, is used to store prawn traps. An aluminum railing surrounds the perimeter of the extension.

In 1990, modifications were made to the vessel, including replacement of the old wooden deckhouse with an aluminum one. An aluminum platform extension to the after end of the vessel was also added for storing prawn traps. The high platform was located at bulwark level, in line with the aftermost step in the main deck. A marine consultant's calculation showing the comparative weights of the old wooden and new aluminum deckhouses was submitted to TC.

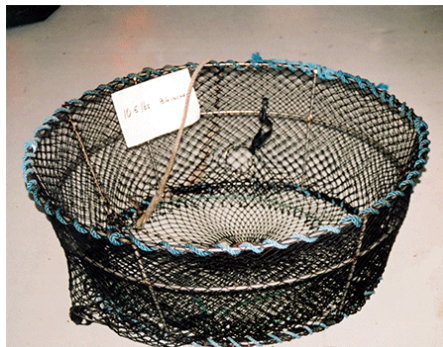
At one time, the more commonly used prawn traps were of the “bucket type.” They were shaped like buckets with their bottoms removed and substituted with a netting and a grab line. Fishers got into the habit of tying two of these bucket traps together and using them as a single trap. This arrangement did not segregate the various sizes of prawns well, resulting in an increased catch mortality rate. These traps weighed approximately 0.9 kg each. By 1994, however, most traps were triple-ring cone nesting or wire mesh.

Concerned about conservation and sustainability in the prawn industry stemming from inappropriate use of the older bucket-type prawn traps, DFO set the upper limits for traps by volume and mesh size in 1995. The specifications were set at 170 litre volume and 38.1 mm mesh size, but no consideration was given to the weight of the traps. When licence holders acted to make their traps more robust and keep their volumetric shape and size, the weight of traps increased from 2 kg to 5 kg.
