MARINE INVESTIGATION REPORT

M02W0135

SWITCHBOARD FIRE

PASSENGER VESSEL *STATENDAM*
STRAIT OF GEORGIA, BRITISH COLUMBIA
04 AUGUST 2002

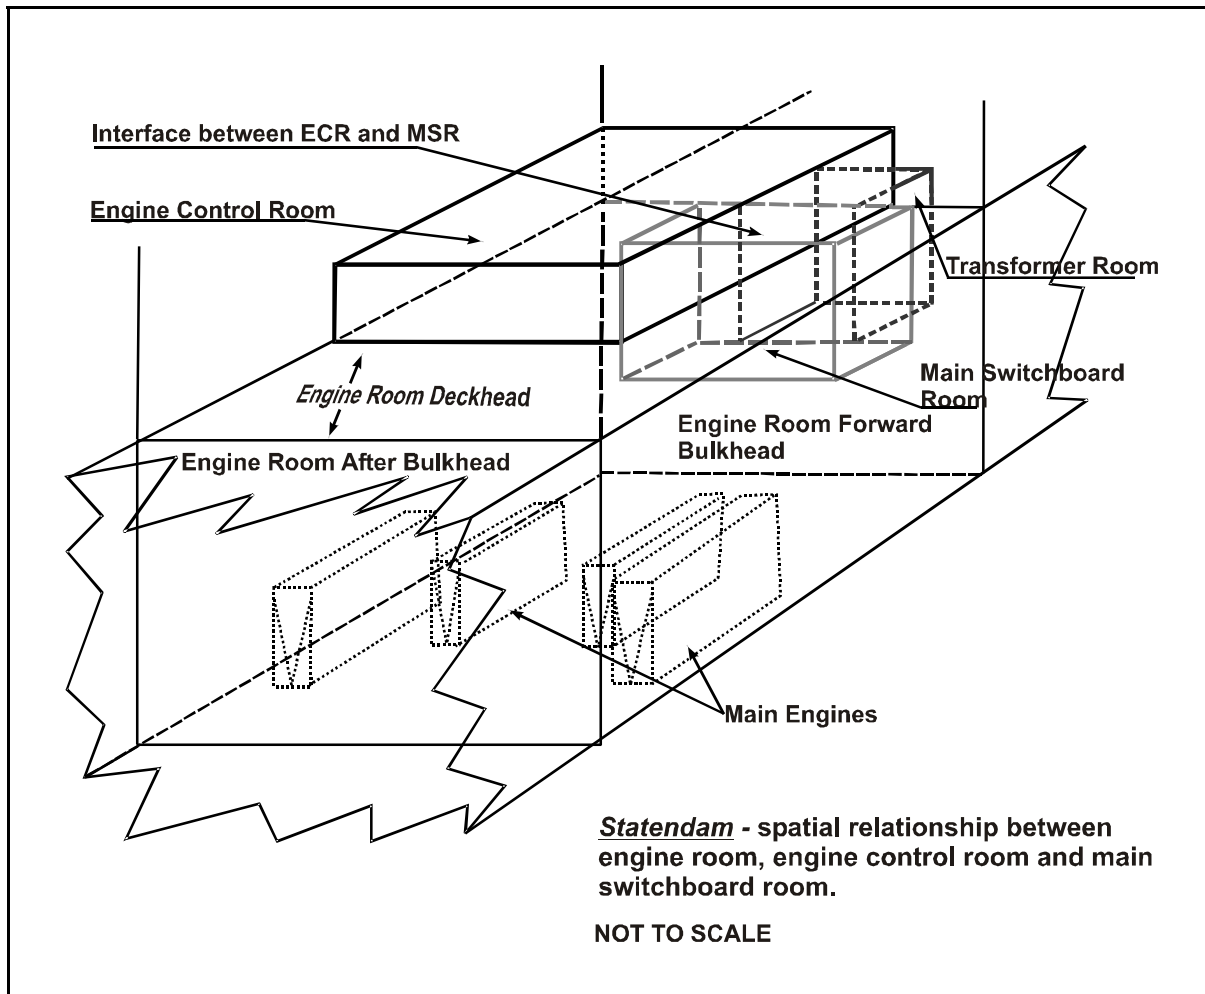
Figure 3. Spatial relationship

The MSR is located within the vertical and horizontal boundaries of the propulsion machinery space with three adjacent compartments: the engine control room, the transformer room and the fuel injector test room (see figures 3 and 4 at Appendix C).
