Transportation Safety Board
of Canada

MARINE INVESTIGATION REPORT
M12L0147

GROUNDING

BULK CARRIER *TUNDRA*
SAINTE-ANNE-DE-SOREL, QUEBEC
28 NOVEMBER 2012

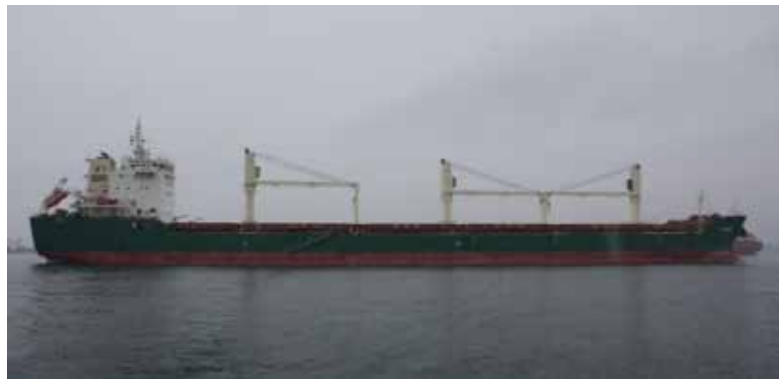
Photo 1. *Tundra*

The *Tundra* is a bulk carrier with machinery and accommodation spaces located aft (Photo 1). The vessel has 6 cargo holds that are serviced by 3 electric-hydraulic cranes mounted on the vessel's centreline. Each crane has a lifting capacity of 30 tonnes.
