MARINE INVESTIGATION REPORT
M15A0009

BOTTOM CONTACT
ROLL-ON ROLL-OFF PASSENGER FERRY *GRACE SPARKES*
BURNSIDE, NEWFOUNDLAND AND LABRADOR
21 JANUARY 2015

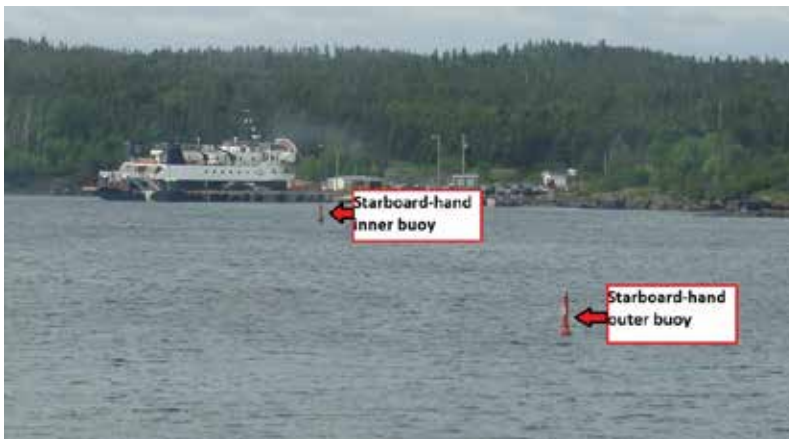
Photo 2. Starboard-hand buoys designating the Burnside channel

There were 2 starboard-hand buoys and 1 port-hand marker in the area of the occurrence (Photo 2 and Photo 3). The 2 buoys indicated the starboard boundary of the channel. The marker indicated the location of Burnside Rock, but did not indicate the port boundary of the channel.
