## MARINE INVESTIGATION REPORT M15A0348

### **Person overboard and subsequent loss of life**

Small fishing vessel *Cock-a-Wit Lady*  
23 nautical miles SSW of  
Clark's Harbour, Nova Scotia  
30 November 2015

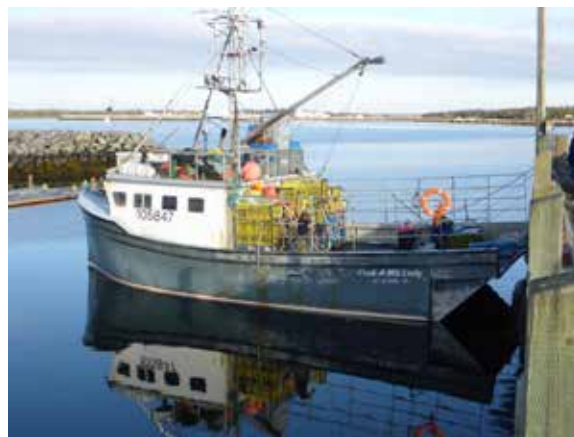
Photo 1. *Cock-a-Wit Lady*

The *Cock-a-Wit Lady* is a small, open-construction fishing vessel of the Cape Island design, built from moulded, glass-reinforced plastic. The wheelhouse and accommodation are forward of midships, and the engine room is beneath the wheelhouse (Photo 1). The wheelhouse can be accessed via doors on its starboard and aft sides. Access to the engine room is through a covered hatch in the wheelhouse.
