MARINE INVESTIGATION REPORT

M16P0062

Grounding of barges

Tug *H.M. Scout* towing barges *HM Blue Horizon*
and *HM Tacoma*

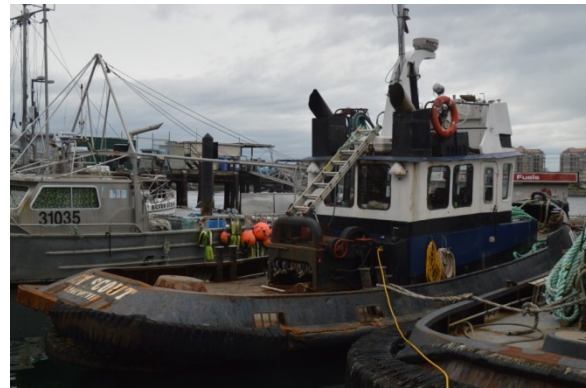
Figure 1. *H.M. Scout*

The *H.M. Scout* (Figure 1) is a single-screw steel hull tug of closed construction¹ built in 1961. It has a plumb stem² and rounded transom stern. The hull below the open main deck is subdivided by 3 transverse watertight bulkheads that enclose 4 compartments (from forward): a void space, a crew accommodation space, the engine room, and the lazarette.

Following the occurrence, the tug's main engine was inoperative due to overheating and required a complete overhaul. The propeller shaft was bent and the propeller's blade tips were damaged.

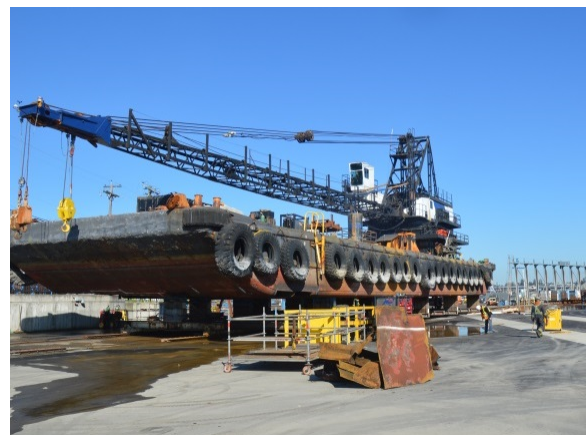
Figure 2. *HM Tacoma*

The *HM Tacoma* (Figure 2) is a welded steel barge with a flat deck and raked bow and stern. The barge is subdivided into 11 compartments by way of 2 longitudinal and 4 transverse watertight bulkheads. A 37-ton revolving crane is fitted aft and is powered by a diesel engine. Fuel for the diesel engine is stored in an independent storage tank located inside the crane housing.

12-inch bitts.³ These bitts are affixed at an angle (45 degrees from the centreline) to facilitate towing. On the aft end of the barge, there are bitts on both the port and starboard sides. The bitts on the port side are aligned parallel to the vessel's centreline. The aft-most bitt on the port side is 25 cm from the stern. The bitts on the starboard side are aligned perpendicular to the vessel's centreline and are 75 cm from the stern.

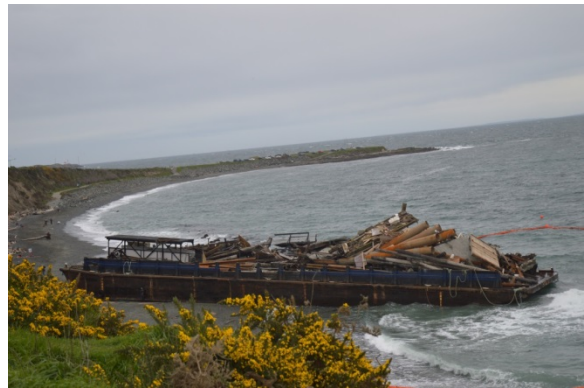
Figure 3. *HM Blue Horizon*

The *HM Blue Horizon* (Figure 3) is a welded steel barge with a flat deck and raked bow and stern. The barge is subdivided into 8 compartments by way of 1 longitudinal and 4 transverse watertight bulkheads. At the forward end of the barge, there are 8-inch towing bitts fitted on the port and starboard sides. These bitts are welded at an angle (45 degrees from the barge's centreline) to facilitate towing. There is an 8-inch bitt fitted on each side of the barge's aft end. Ladders are affixed to each side of the barge for boarding and disembarking of personnel.

The barge has a design draft of 2.9 m; the draft marks are not marked on the hull, nor is this required by regulation. At the time of the occurrence, the barge had an estimated draft of 0.6 m and a freeboard of 2.69 m.
