MARINE INVESTIGATION REPORT

M00W0303

STRIKING OF A BRIDGE

TUGBOAT *MILLER RICHMOND* AND  
BARGES *MILLER 201* AND *MILLER 206*  
PITT RIVER HIGHWAY BRIDGE, BRITISH COLUMBIA  
18 DECEMBER 2000

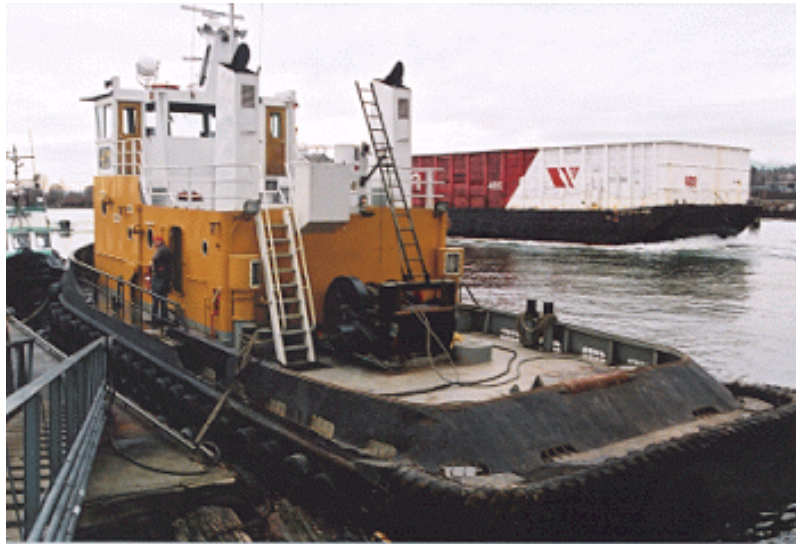
The tug is powered by two diesel engines driving twin fixed-pitch propellers, with twin rudders for each propeller. The wheel-house is well laid out, with propulsion controls arranged on the main console amidships. A second control console is located at the after end of the boat deck abaft the funnels. Both control stations are fitted with pneumatic abort systems to allow the cable to run freely off the towing winch drum in the event of an emergency.

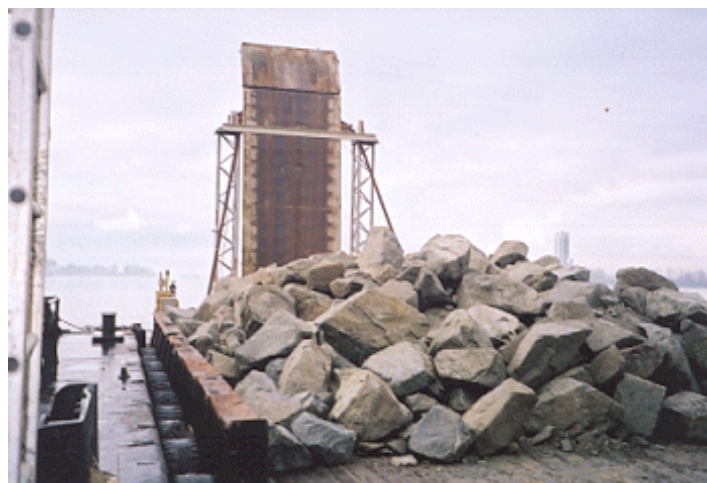
*Barges Miller 201 & Miller 206*

Both barges of steel construction, are flat decked, non-self-propelled and unmanned. The *Miller 201* (See Photo 2) is fitted with a hydraulically-operated stern ramp. In the stowed position, the ramp has a vertical height of 12 m, and requires the Pitt River Highway Bridge to be swung open to enable transit.
