LARGE MAMMAL-VEHICLE COLLISIONS:

OVERVIEW OF MITIGATIONS AND ANALYSIS OF COLLISIONS IN YUKON

March 2015

MRC-15-02

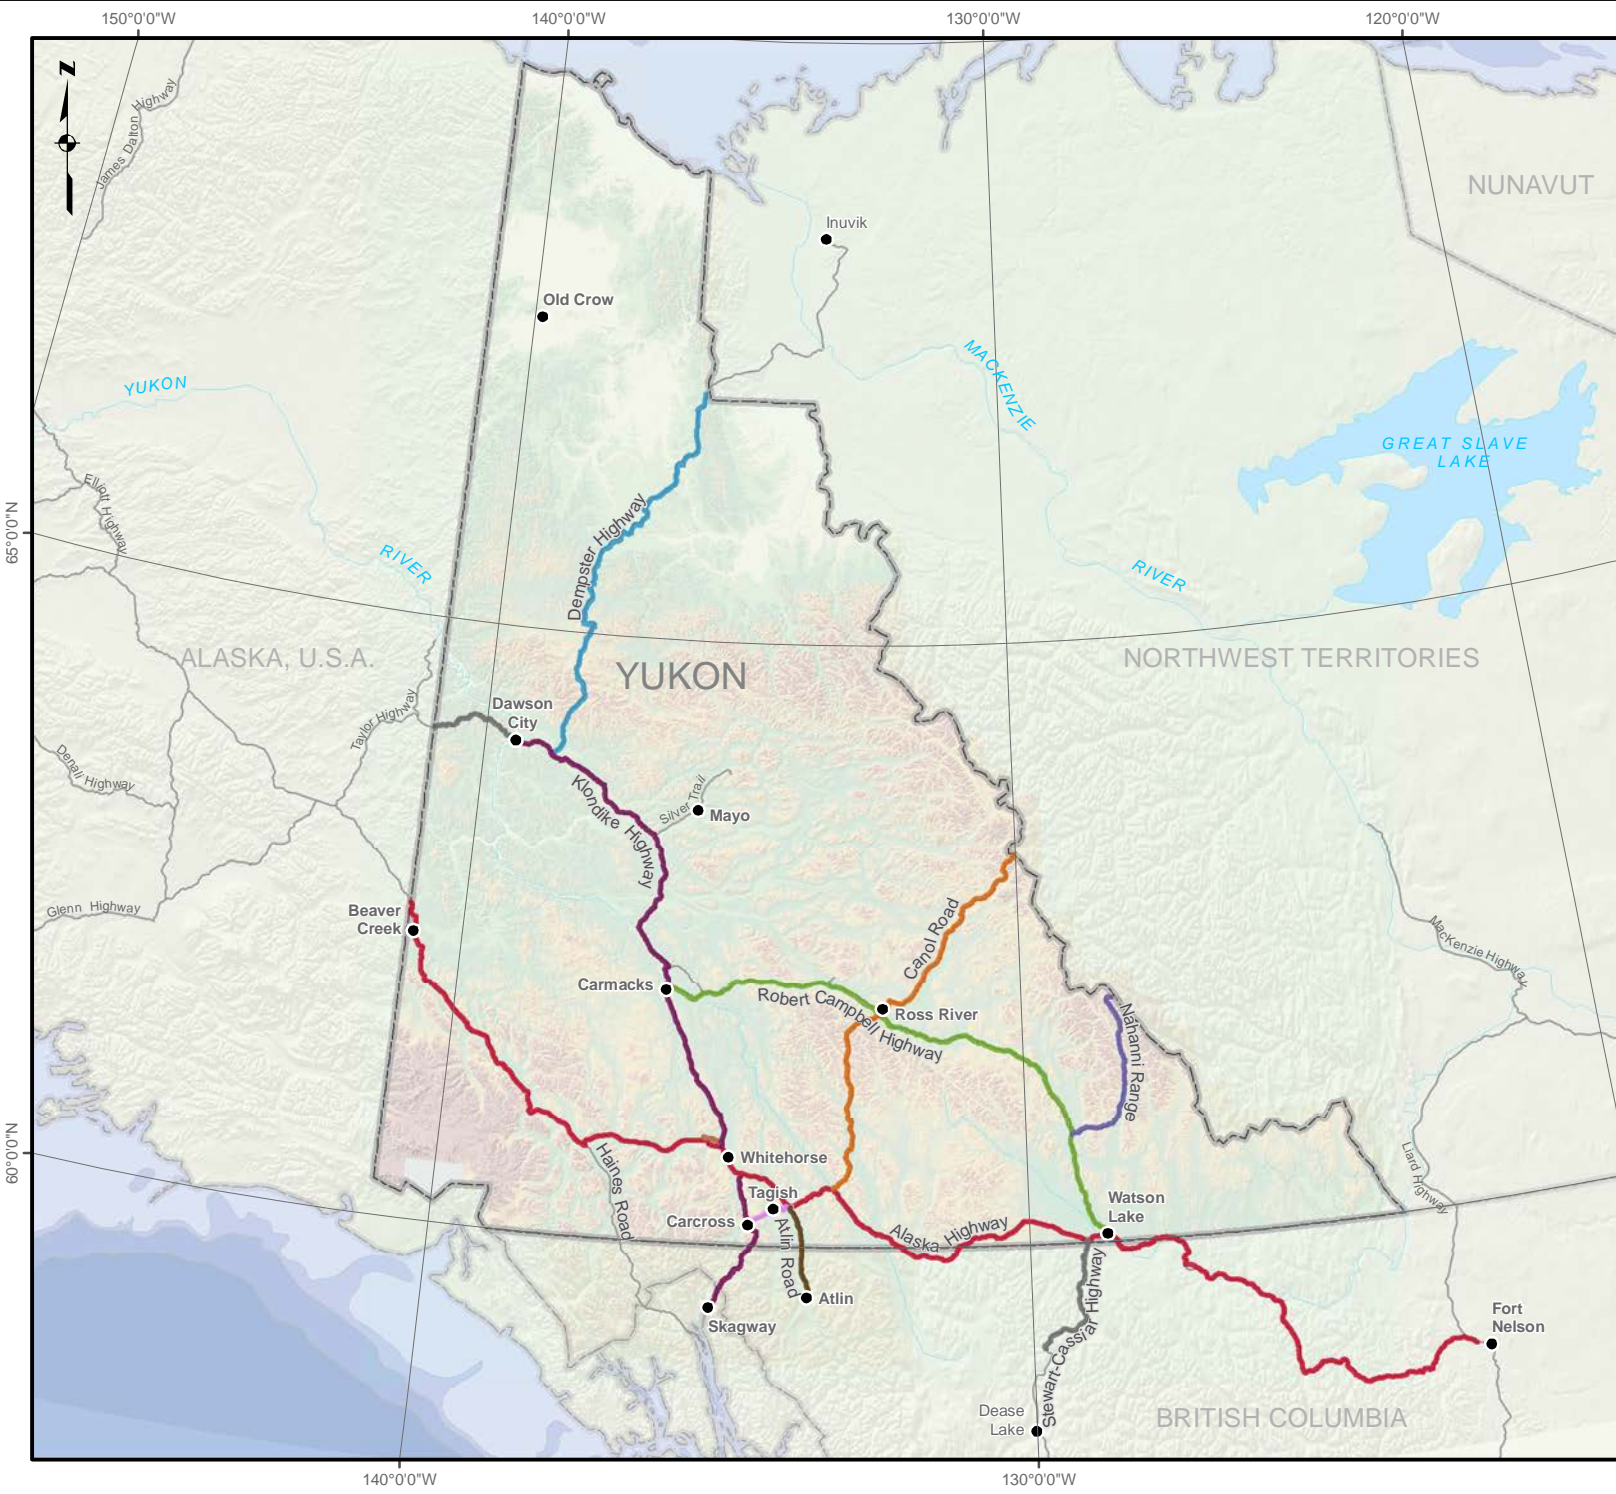
An overview of the Yukon highways and roads included in the WVC analysis is provided in Figure 2. A list of highways and roads with their average daily traffic count is provided in Table 4. Some roads included in the analysis are territorial highways while others are high use roads. Herein, all roads included in the analysis are referred to as highways regardless of being labelled a road or highway.

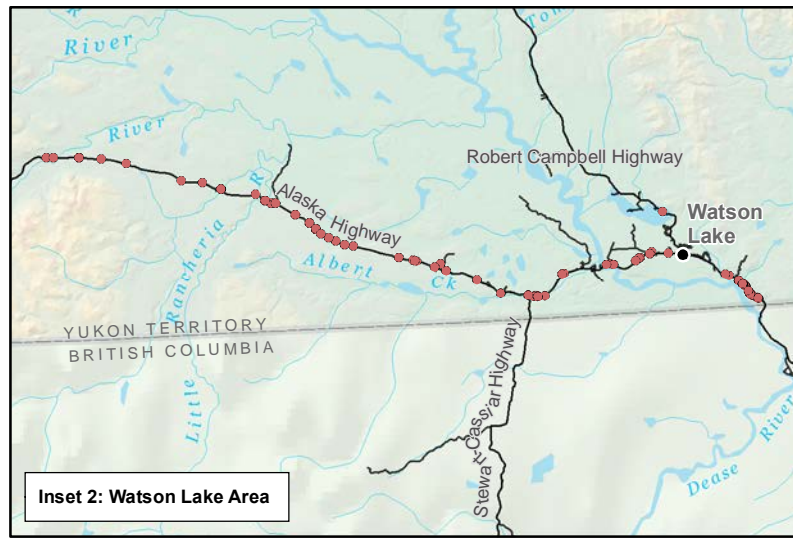
Created: MP/LG	Checked: LP	Date: 12/01/2015	FIGURE 5
-------------------	----------------	---------------------	---------------------------

Locations of caribou-vehicle collisions, 2003 – 2014

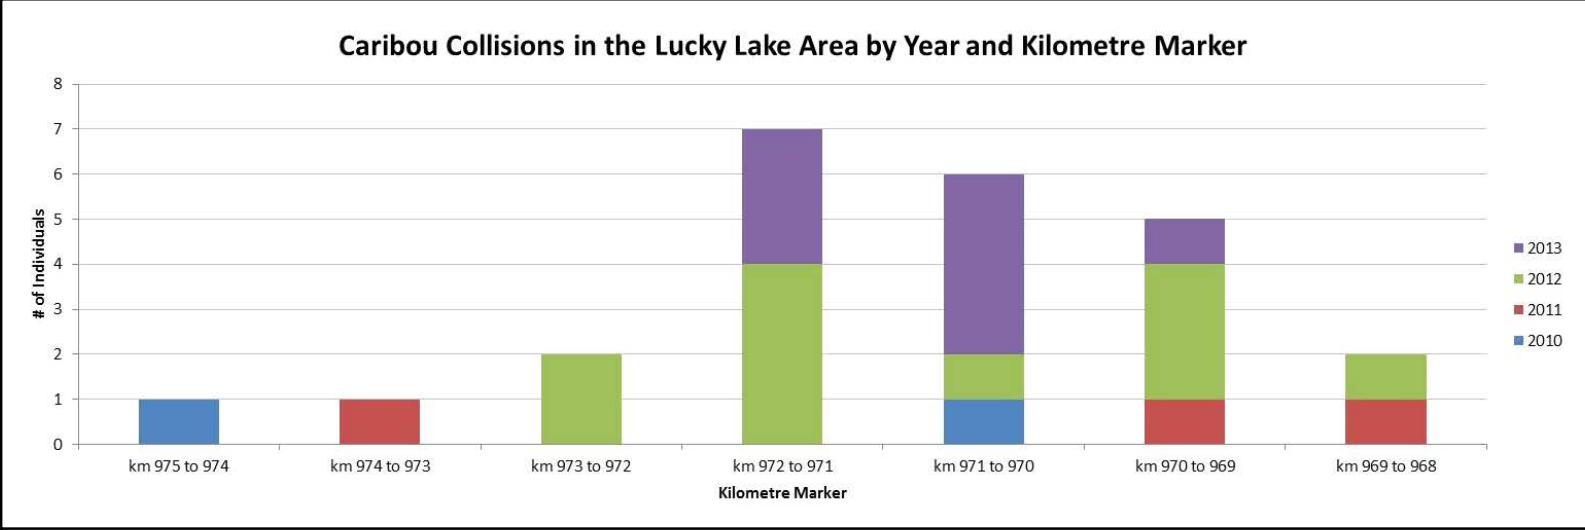
Caribou-vehicle collisions in the Lucky Lake area, 2003 – 2014

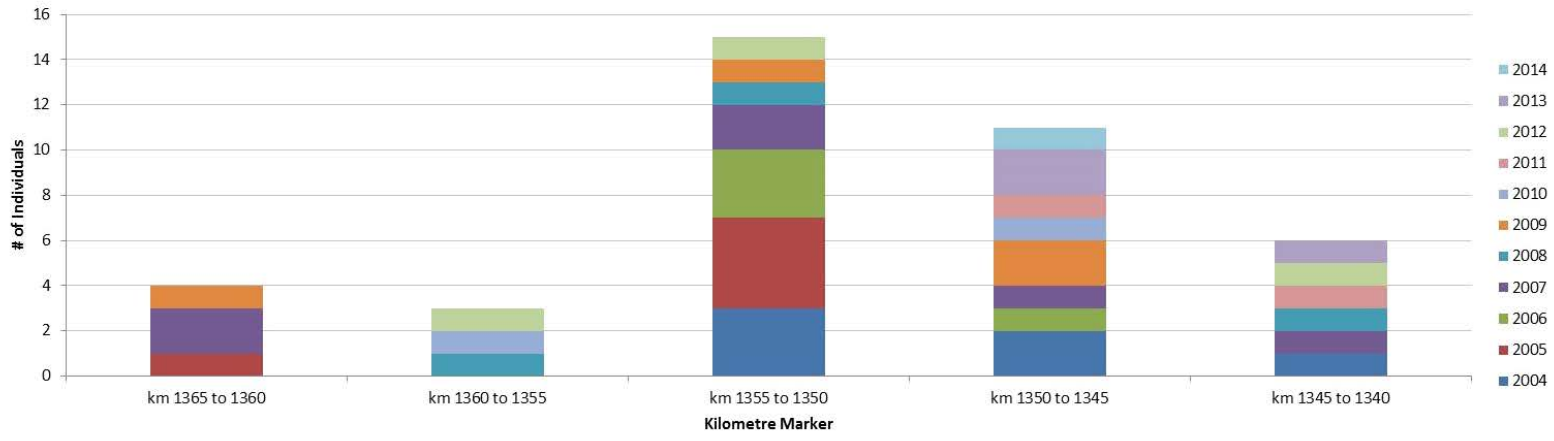
Caribou Collisions in the Jake's Corner Area by Year and Kilometre Marker

Caribou-vehicle collisions in the Jake's Corner area, 2003 – 2014

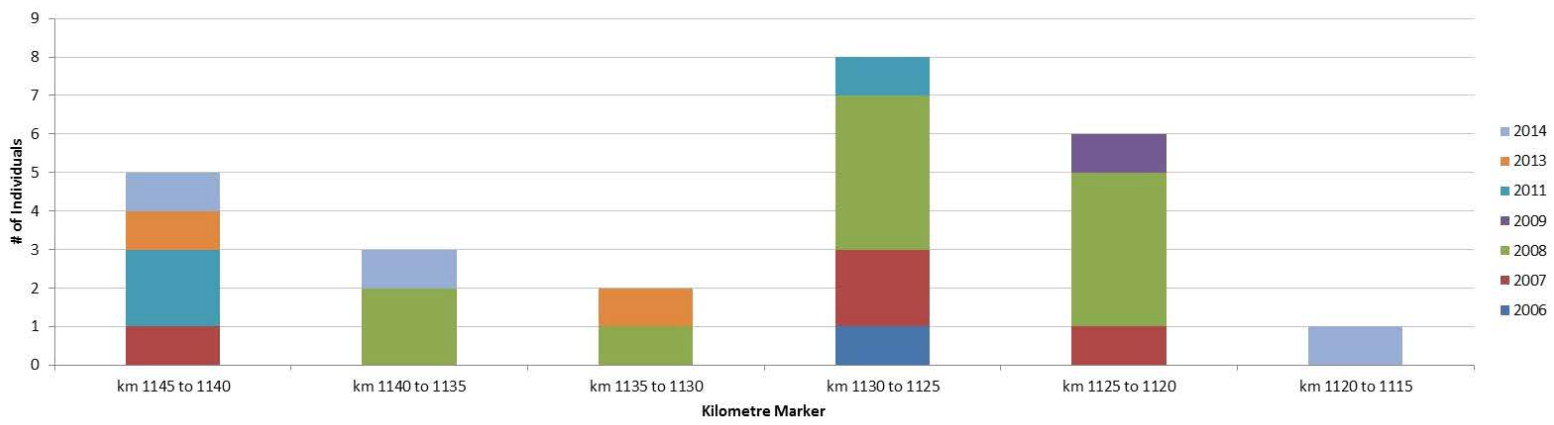
Moose Collisions in the Swift River Area by Year and Kilometre Marker

Moose-vehicle collisions in the Swift River area, 2003 – 2014

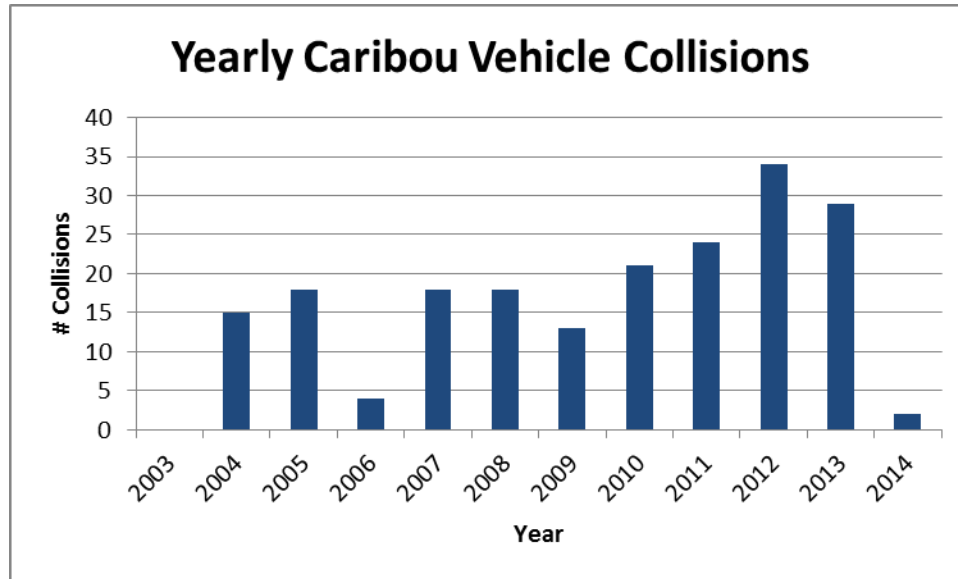
Figure B1. Count of caribou-vehicle collisions by year, 2003 – 2014.

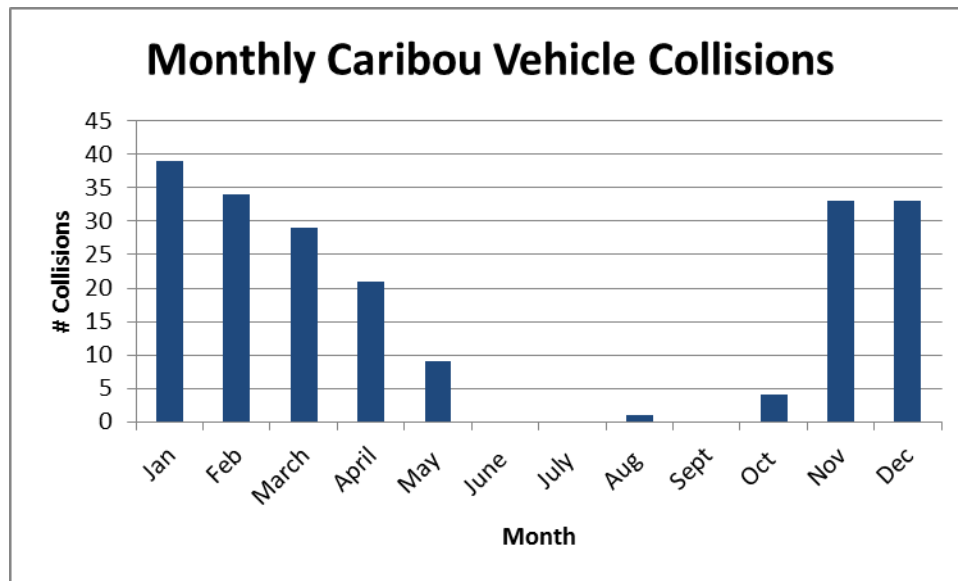
Figure B2. Variation by month in caribou-vehicle collisions, 2003 – 2014.

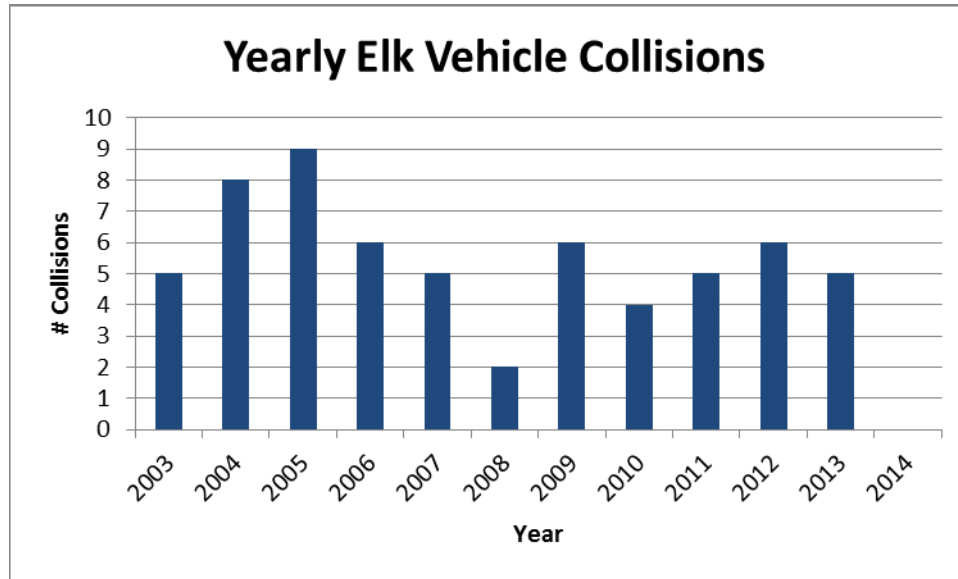
Figure B5. Count of elk-vehicle collisions by year, 2003 – 2014.

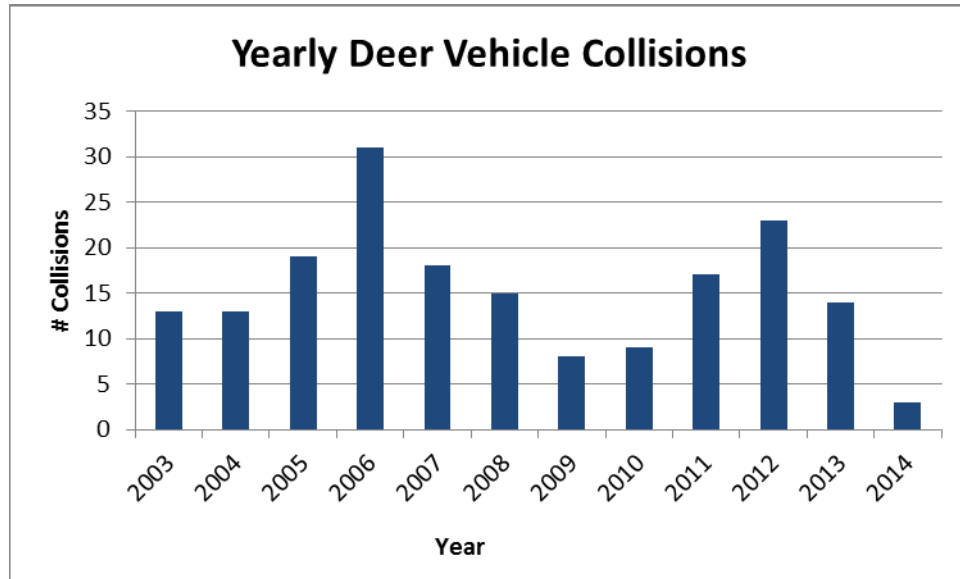
Figure B7. Count of deer-vehicle collisions by year, 2003 – 2014.

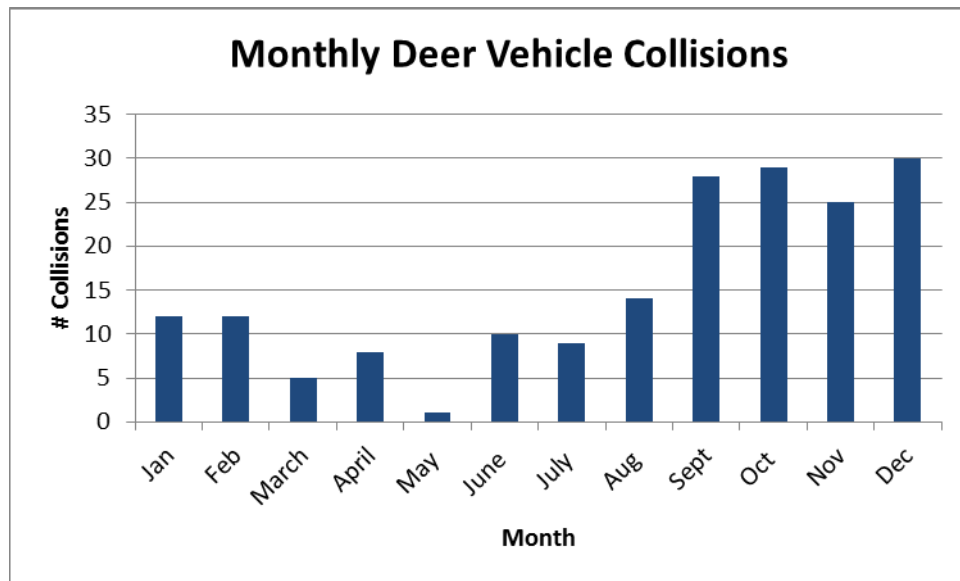
Figure B8. Variation by month in deer-vehicle collisions, 2003 – 2014.

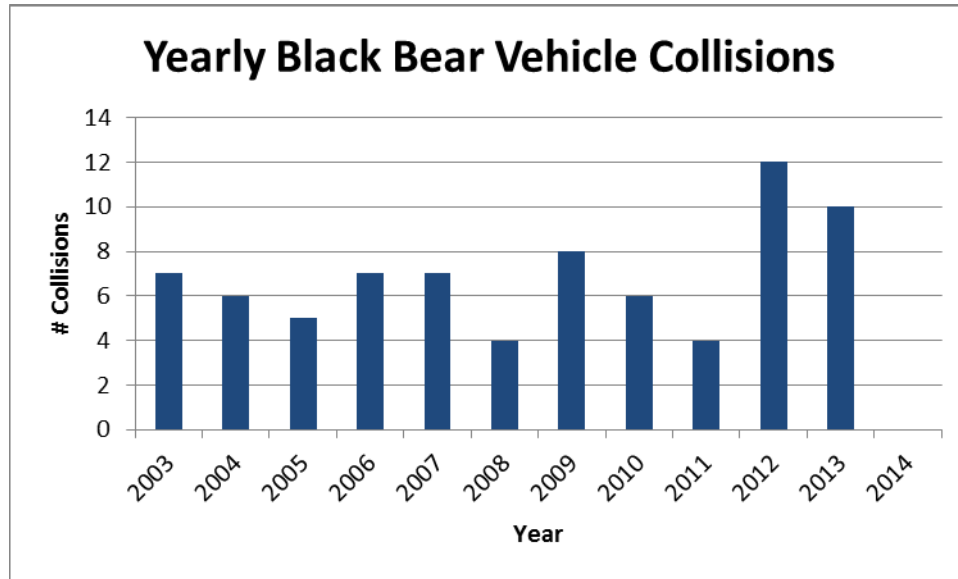
Figure B11. Count of black bear-vehicle collisions by year, 2003 – 2014.

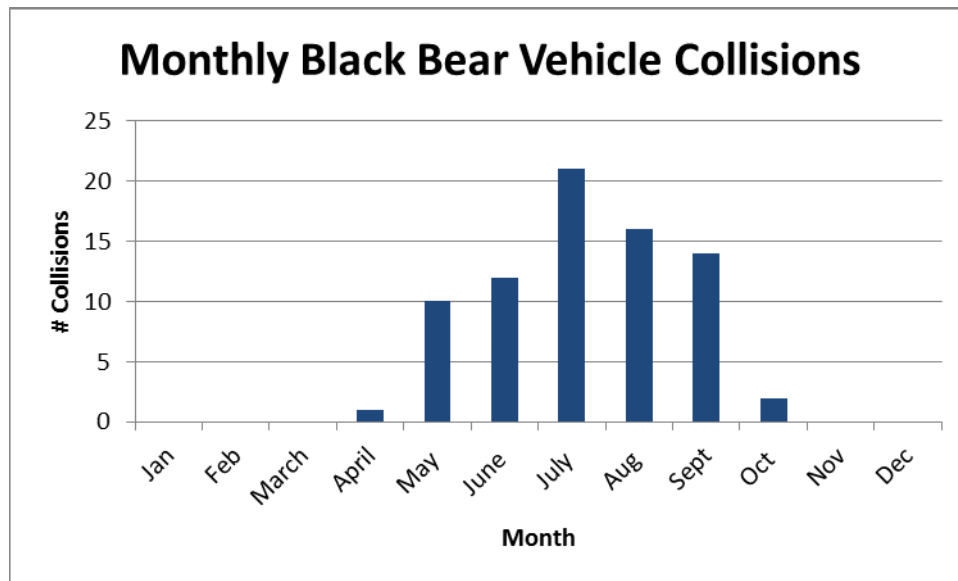
Figure B12. Variation by month in black bear vehicle collisions, 2003 – 2014.
